EAST NETHERSHIELDS ROAD SAFETY REVIEW OF TIMBER EXTRACTION JUNCTION

ROAD SAFETY REVIEW
(SPA Ref No: 5564)

Roads Authority: South Lanarkshire Council

Client: Tilhill

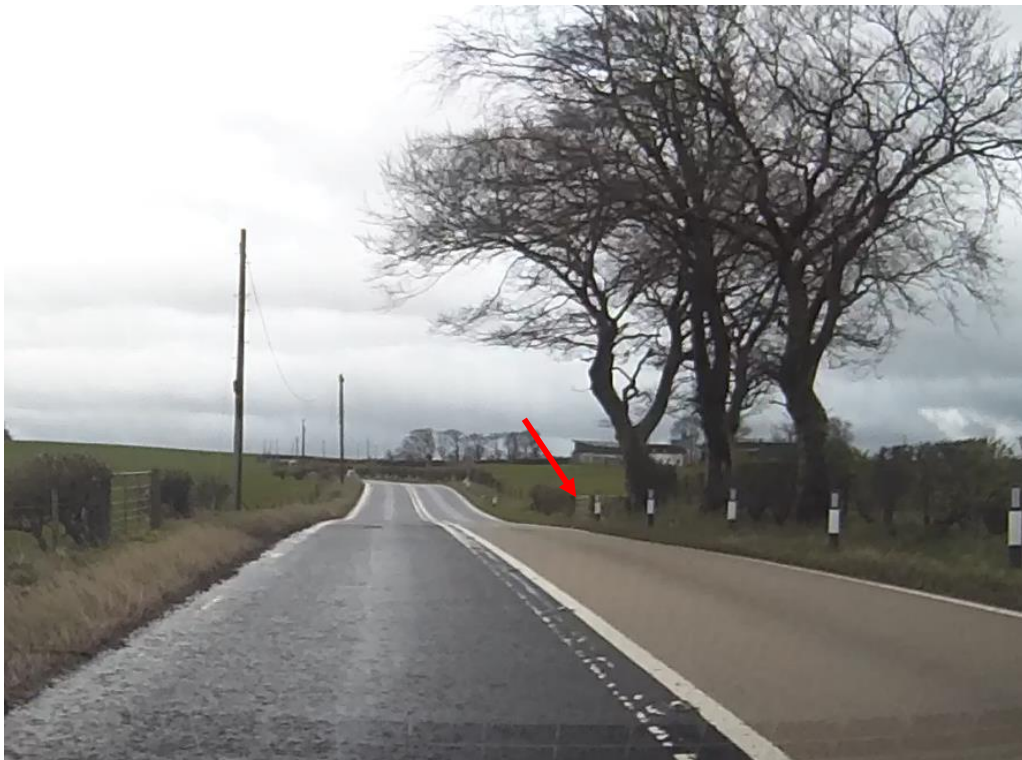
View of the existing field access when travelling south on the A723

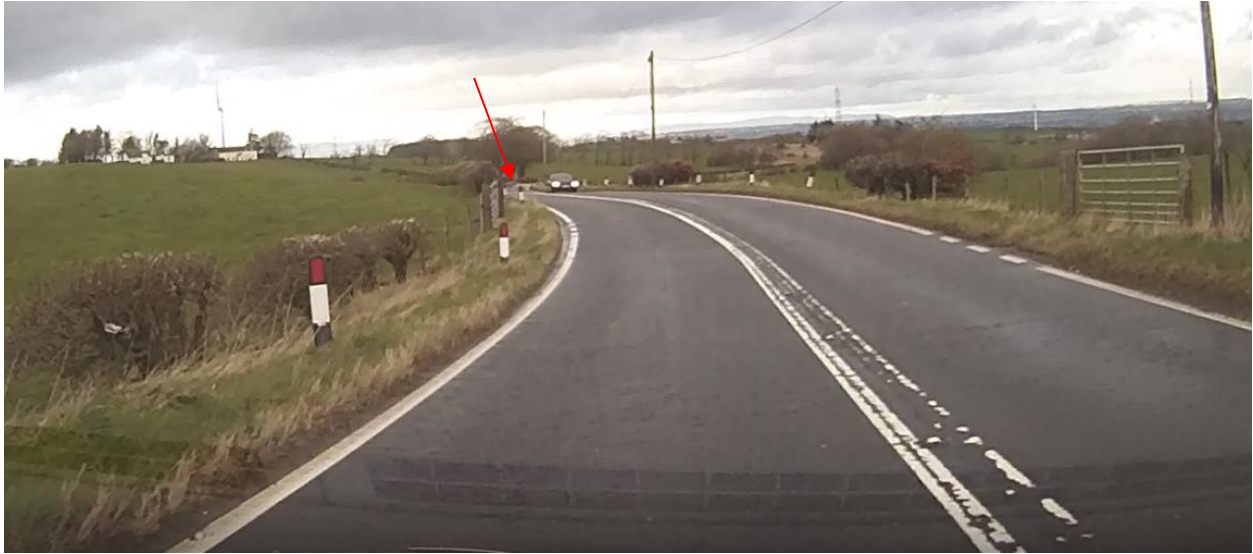
- 5.7 When considering the northbound approach to the access junction the SSD of 215m is probably just being met in the horizontal plane. However, the view to the lower object height of 0.6m in the vertical plane may be restricted.

- 5.8 The SSD of around 215m looking northwards can be seen in the image below. The access junction location is highlighted at the trees in the middle of the image.

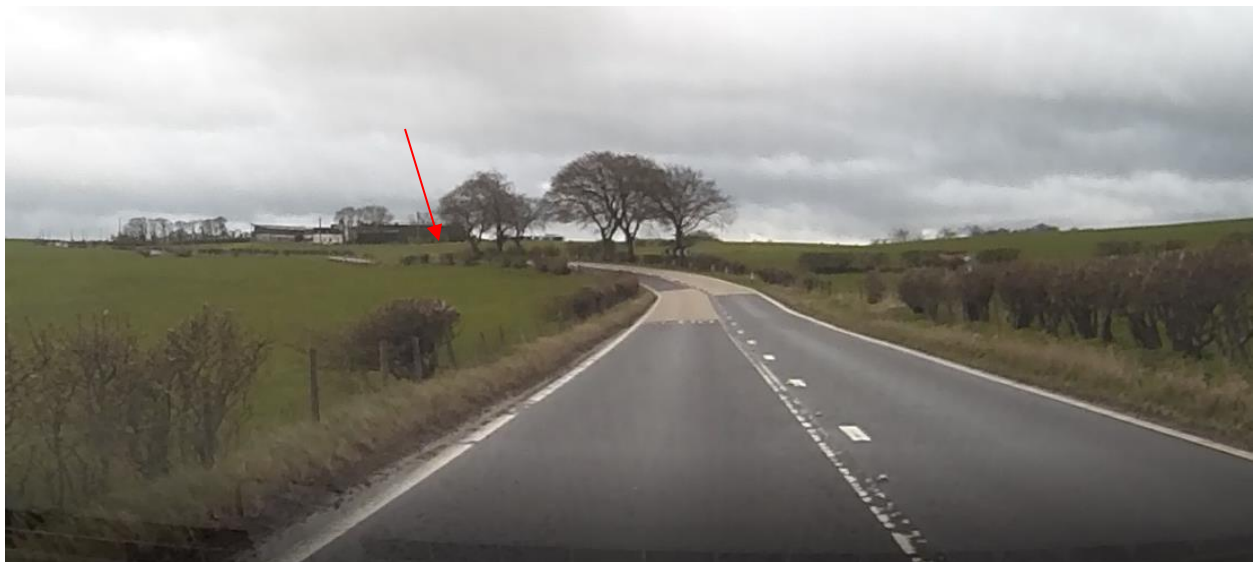
- 5.9 When looking southwards the horizontal curvature is more onerous and the 215m SSD cannot be achieved as the view crosses over the field on the east side of the road.

- 5.10 In this circumstance there may be no control by the roads authority or any 'developer' over the land to the east of the A723.
- 5.11 It is estimated that the SDD on the southbound approach to the access junction is only in the region of 100m.
- 5.12 In addition to this, the image below shows there is a vertical crest that restricts the forward visibility to the carriageway to the south of the junction.

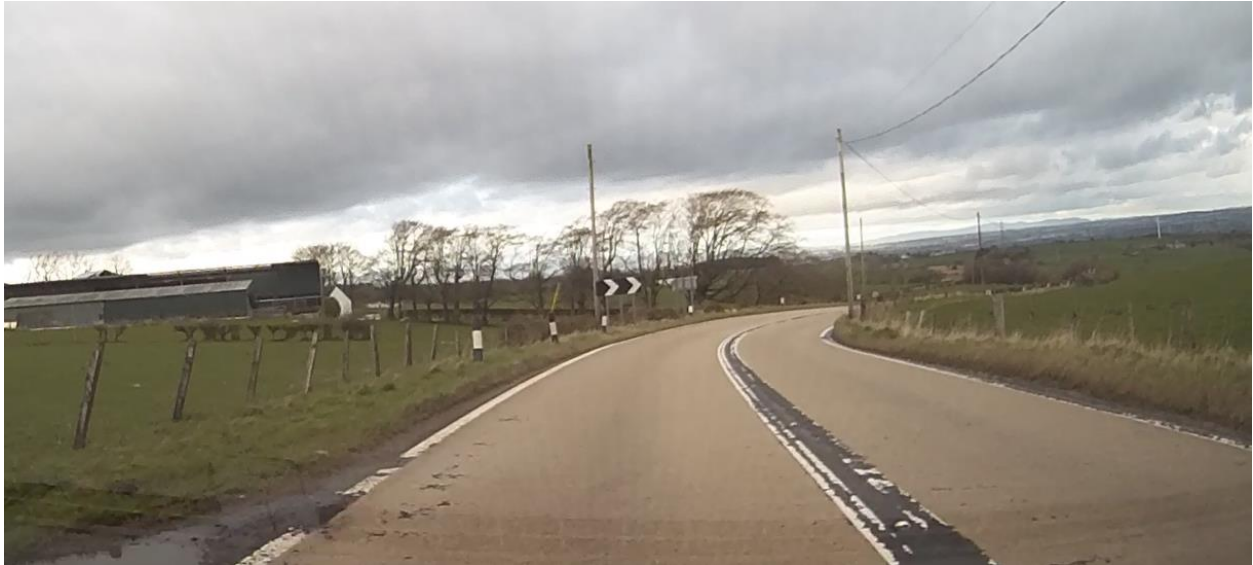
- 6.7 The collision that occurred on 16 July 2020 between the two access junctions for Nethershields Farm appears to be related to two opposing vehicles colliding at the bend in the carriageway. It is assumed that there has been a loss of control where crossing of the centre line has occurred.

Northbound view of location of the slight injury collision on 16 July 2020

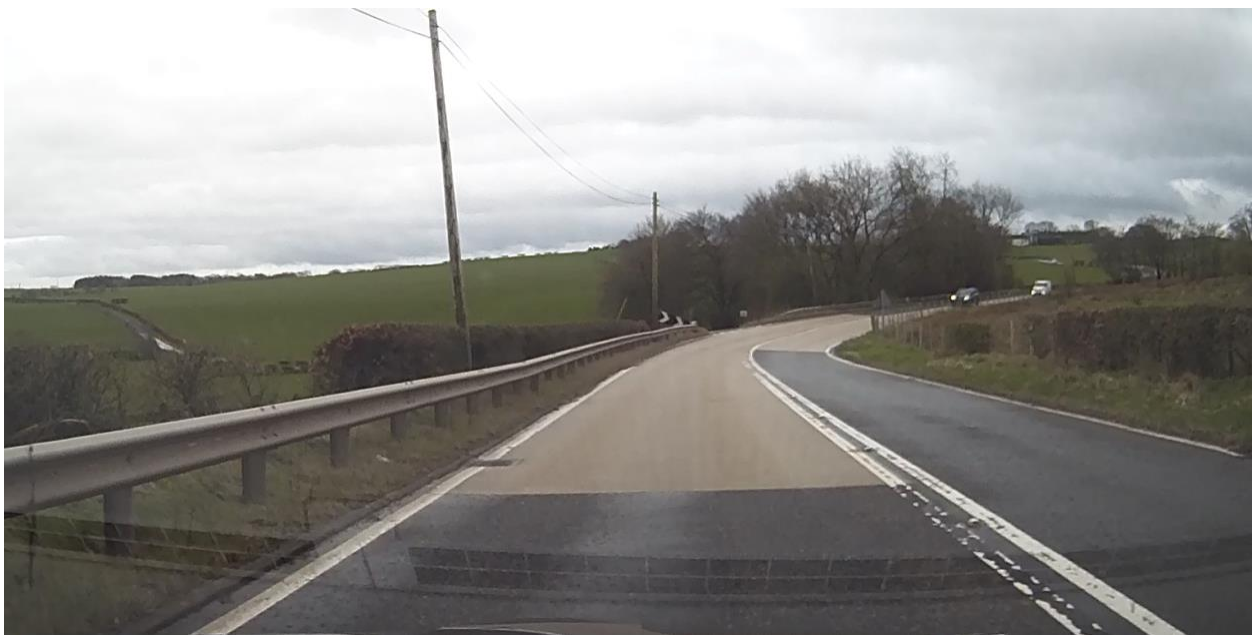
- 6.7 The serious collision directly to the north of the access junction on 13 October 2022 appears to be the result on a collision involving turning traffic at the junction that leads to Shotlinn Farm.

Southbound view of location of the serious injury collision on 13 October 2022

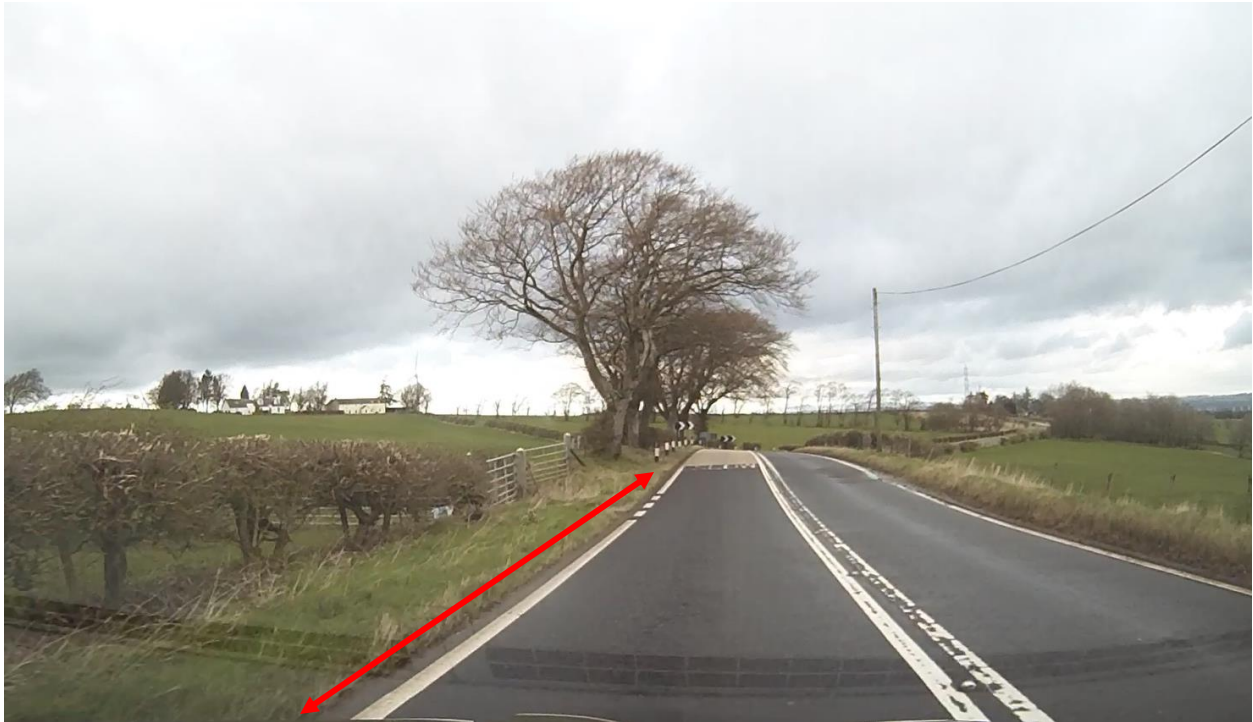
7.5 The hedgerow to the south would have to be cleared and it is likely the bell mouth would need to extend to the limits shown below.

- 7.6 This would then result in the centre of the junction being to the south of the vertical crest at the trees.
- 7.7 The result of this is that the required visibility splay in both directions is likely to be reduced.

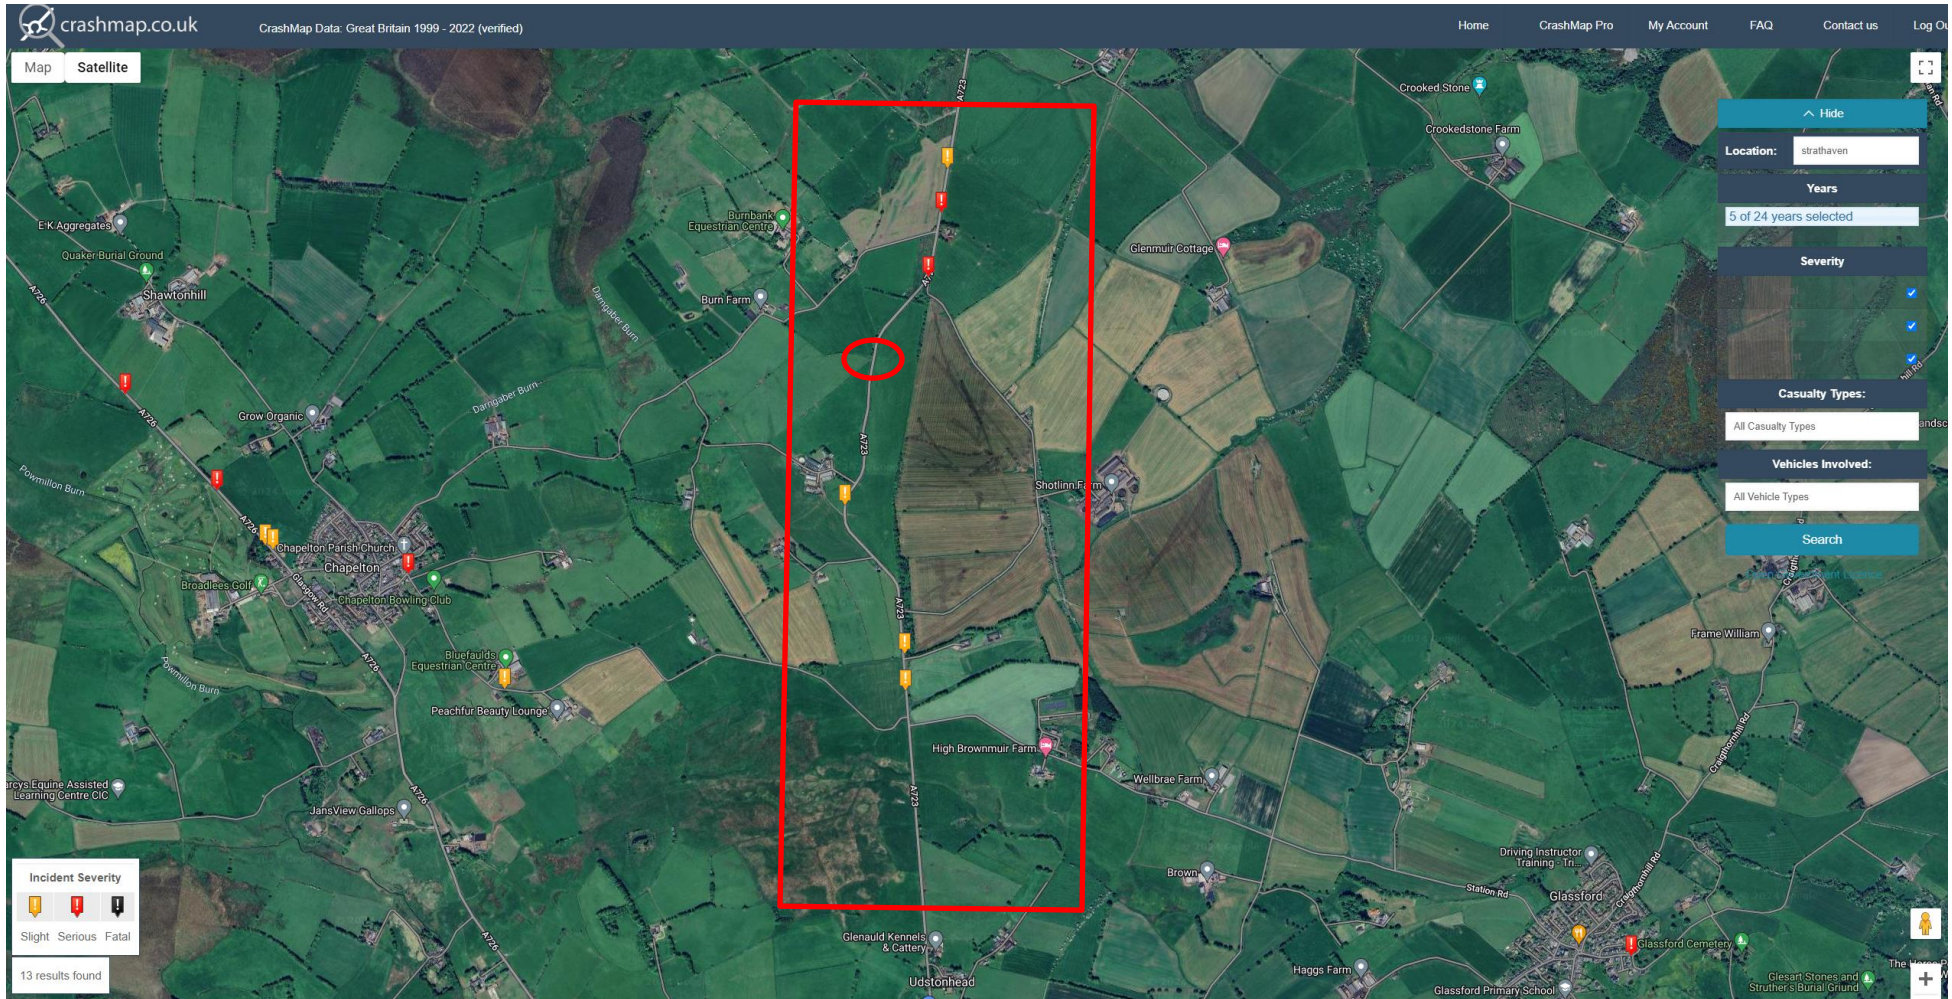
- 6.4 The location of the collisions can be seen in Annex 1.
- 6.5 There are three slight injury collision to the south of the access junction. To the north there are two serious collisions and then one slight injury collision.

(Map based information of 6 collisions and two site specific details of two collisions closest to the proposed access junction)
