**WOODLAND CREATION SCHEME
EAST NETHERSHIELDS
A723
STRATHAVEN**

ROAD SAFETY REVIEW
(SPA Ref No: 5349)

Roads Authority: South Lanarkshire Council

Client: Tilhill Forestry

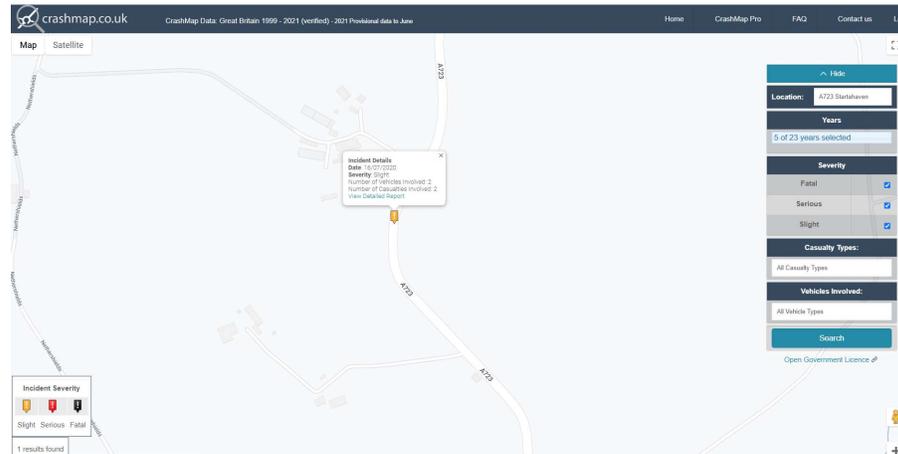
3.2 Accident Location

3.3.1 This collision occurred on the 16 July 2020 at 0830 hours. At the time of the collision, it was daylight, and the weather was dry and fine without high winds. Visibility would have been good. The collision involved two vehicles and two slight injury casualties.

3.3.2 The description of the collision indicates that vehicle number 1, a car, was travelling north on a right-hand bend and was described as proceeding normally along the carriageway. Vehicle number 2, also a car, was travelling south on a left-hand bend and was also described as proceeding normally along the carriageway. Both vehicles sustained damage to the front.

3.3.3 The description of the collision and the damage to the vehicles would indicate that one of the vehicles may have been on the wrong side of the carriageway or has lost control while negotiating the series of bends. There is nothing to indicate that any of the existing junctions or visibility issues were a causation factor in the collision.

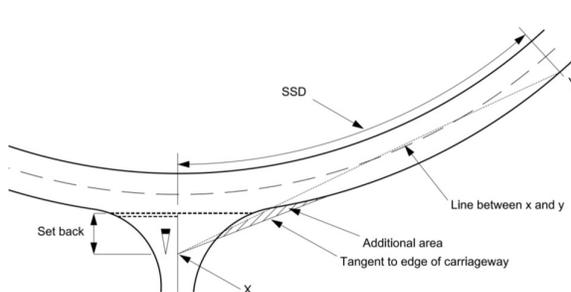
Fig 3.9

The three existing access junctions on the A723, namely Nethersields North, Nethersields South and South Shields are built to differing standards. All three junctions rely on visibility splays which cross adjacent fields. The presence of existing verges, hedges, fencing along with the vertical and horizontal alignment of the carriageway results in visibility splays which are more than likely less than the, 215m DMRB standard, which would normally be expected.

All three junctions lie on the outside of curves and accordingly the visibility splay may have to be constructed as a combination of the guidance outlined in CD123 'Geometric design of at-grade priority and signal-controlled junctions', Figure 3.9 and 3.10.

It is recommended that when designing the final tree line of the woodland creation scheme that all planting is kept clear of visibility splays. The guidance provided in DMRB, CD123 'Geometric design of at-grade priority and signal-controlled junctions' should be followed.

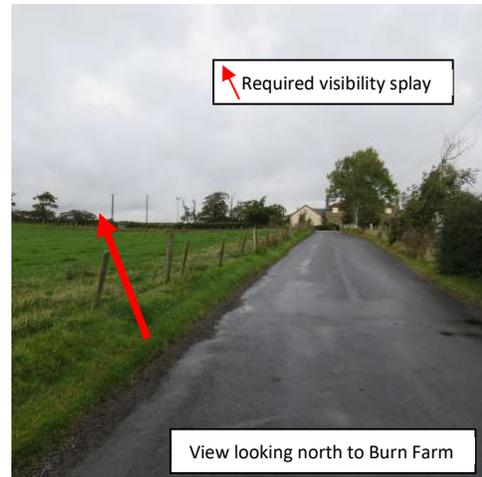
Burn Road is a narrow carriageway and drivers have to negotiate a variety of bends, crest and sags. While forward visibility appears to be adequate in places there are areas where the roads contours and existing verges restrict the forward visibility. At Burn Farm there is a series of sharp bends where drivers need to take a view across the fields in order to observe approaching traffic. Trees planted in this area there will be greatly reduce visibility.

It is recommended that when designing the final tree line of the woodland creation scheme that tree planting in the area of Burn Farm be kept clear of the visibility splay across the fields to ensure that drivers in both directions have clear visibility to approaching traffic.

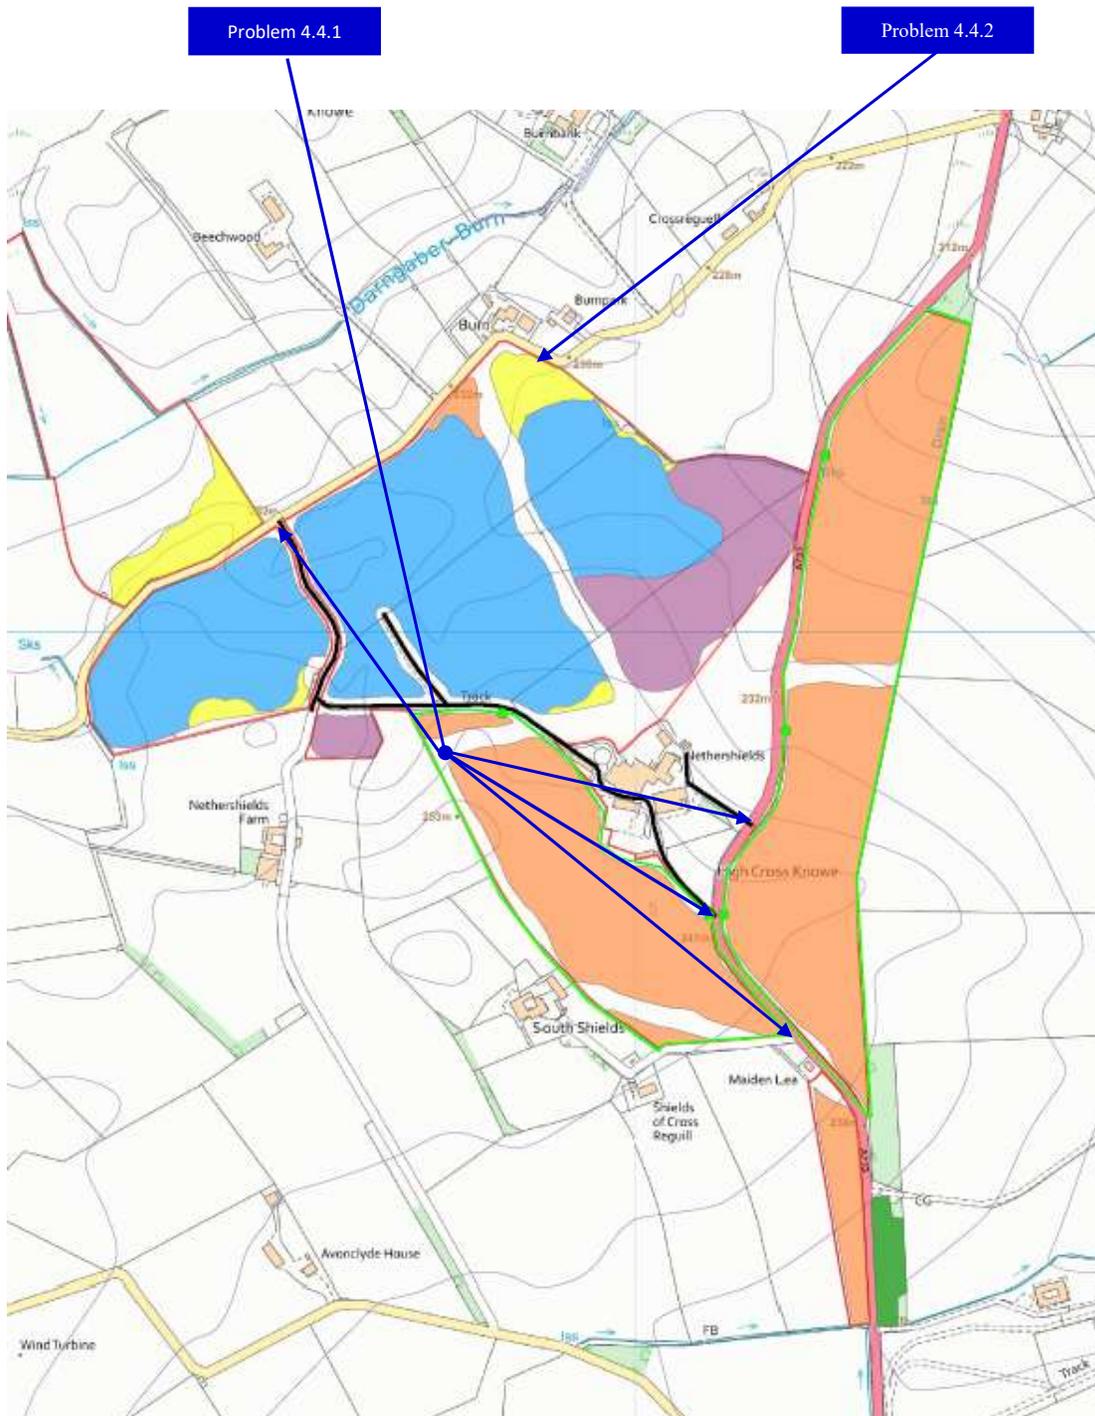
Annex 2 PROBLEM LOCATION PLAN

- Specific problem areas have been identified and referenced by the comment number in the text
- General issues covering multiple areas(4.4.3)have not been highlighted on this plan so as to avoid clutter and potential misinterpretation.
