# **Glen Clova Woodland Creation Scheme**

Historic Environment Desk-Based Assessment  
and Walkover Survey

19 May 2021

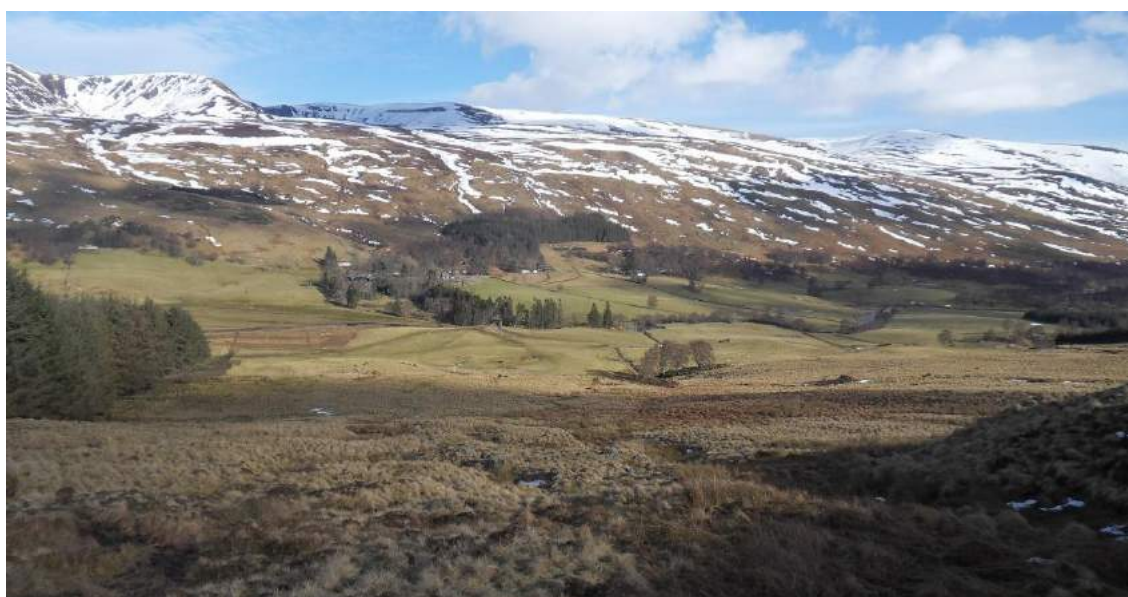
**Photo 1.1: View north-east across Parcel D towards MM20, with Clova in the distance**

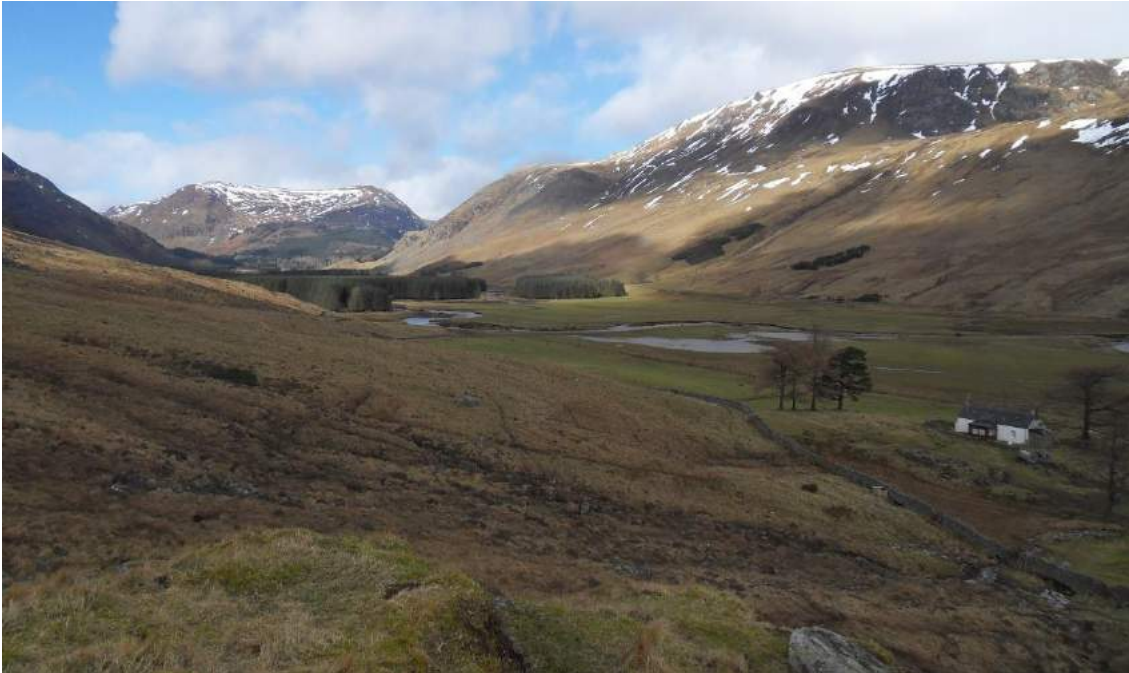
**Photo 1.2: View north across Glen Clova, with Parcel D bordered by the Atton Farmstead in the foreground and Parcel E on the slopes opposite**

Parcel E (Photo 1.2) is the only one of the parcels located on the north side of the River South Esk, on the south-east facing slopes of the series of summits, ridges and corries which make up the north side of Glen Clova. Covering over 614ha, Parcel E is defined by the topography and upper slopes of the hills, the north-eastern boundary encompassing the Corrie of Bonhard, the Corrie of Clova, Brown Holm and the Corrie of Inchdowrie. The eastern edge is marked by a land boundary running along the west side of the Burn of North Inchdowrie. The eastern edge of the south boundary runs on the uphill side of the numerous small woodland plantations above the hotel and other buildings at Clova and Kirkton of Clova, before extending north-westwards along the northern side of the road through the glen. The nature of the landscape means that numerous small unnamed burns are contained within the parcel, running downslope to the River South Esk. In addition to these, the named Burn of Bonhard, Corrie Burn and Burn of Loch Brandy also run through Parcel E. The landscape comprises steeply sloping hillsides, flatter at the base of the parcel immediately north of the road (Photo 1.3).

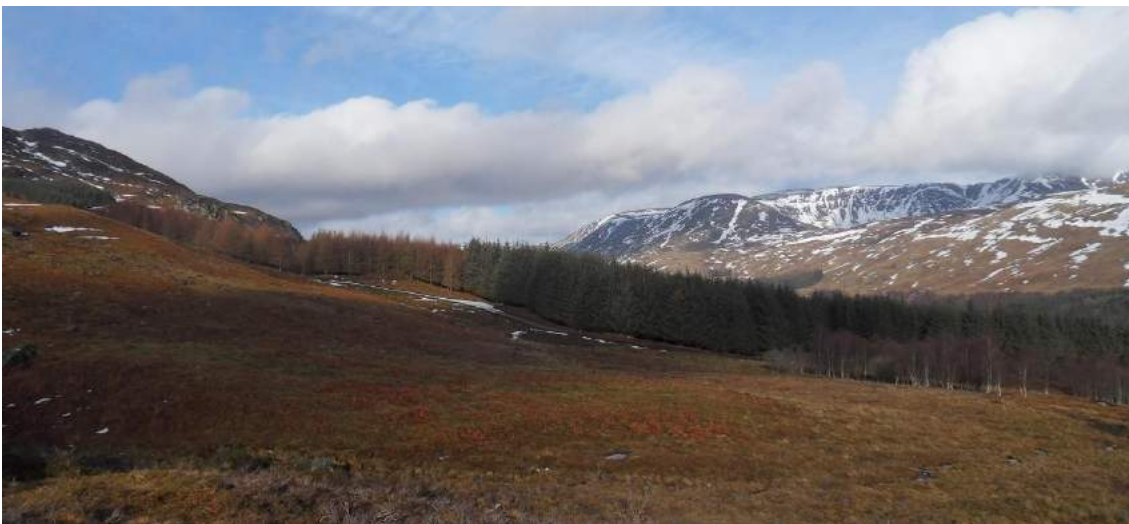
**Photo 1.4: View north-west across the heather moorland within Parcel F**

The landscape of the respective study areas can generally be categorised as sloping heather moorland and rough pasture of varying degrees of steepness, with large rocks and boulders, in some areas very densely concentrated.

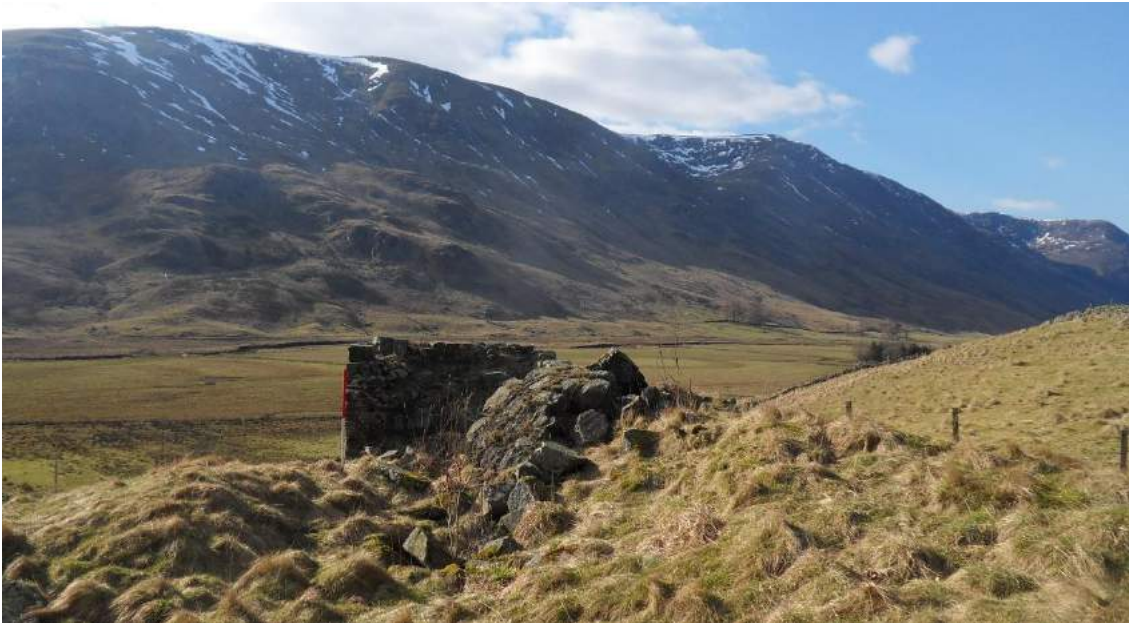
Clova Castle (Photo 4.1) comprises the remains of a fortification of 16<sup>th</sup> century date and is protected under the Ancient Monuments and Archaeological Areas Act 1979. While located outwith the study area, the proximity of Clova Castle (MM01) and the designation as a Scheduled Monument means that it must be considered during the assessment and recommendations provided.

**Photo 4.1: View west across the remains of Clova Castle (MM01)**

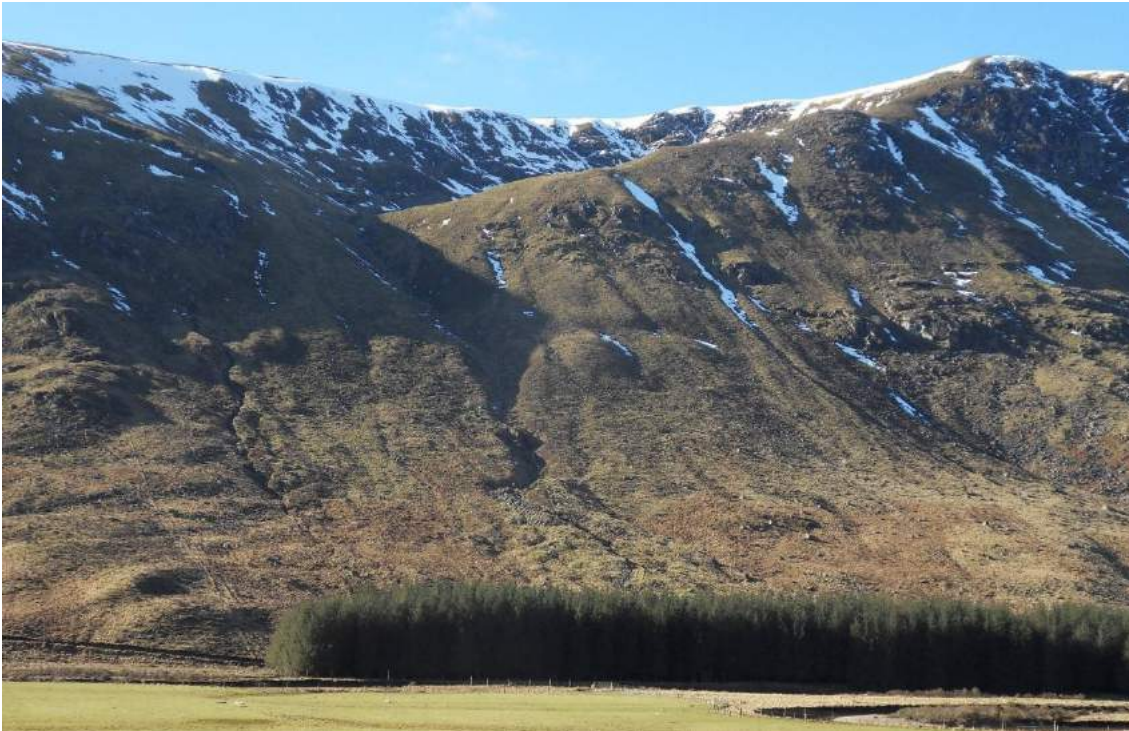
**Photo 4.2: View of the hillside at the north-western end of parcel D, showing evidence for deep ploughing adjacent to the conifer plantation**

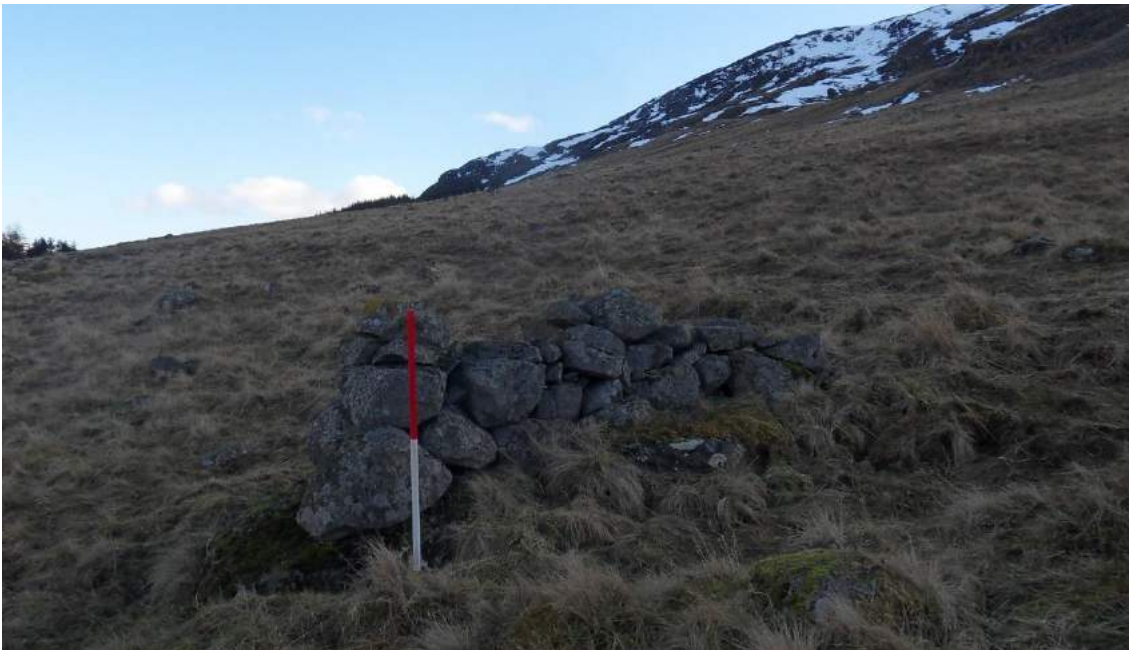
**Photo 4.3: View of grouse butt MM78b looking south-east**

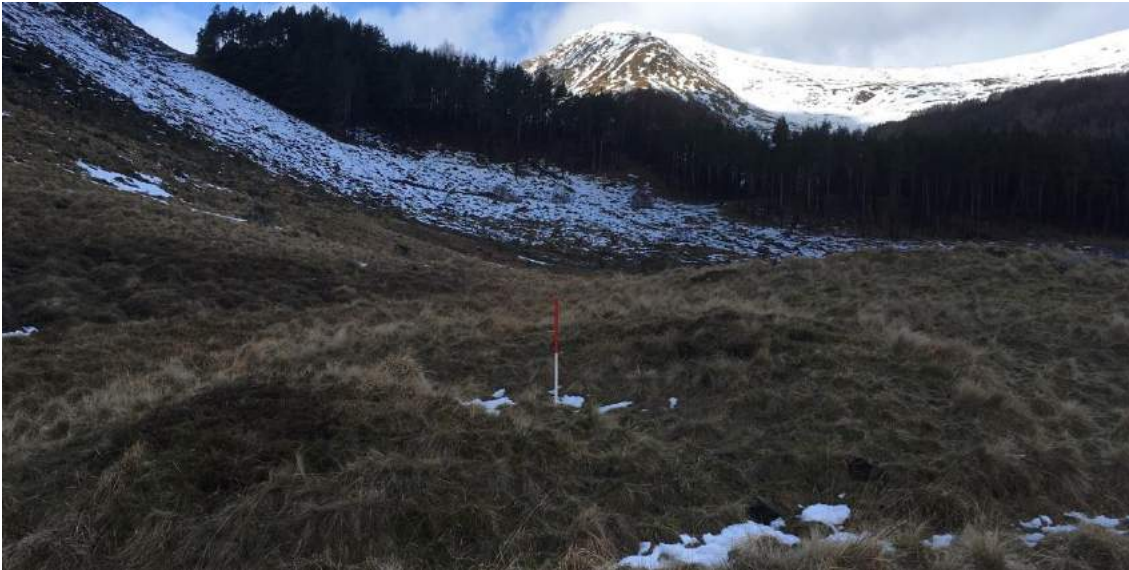
The burnt mound (MM02) in Parcel A (Photo 4.4) was very clearly visible and conformed to the typical pattern of such heritage assets, with steep, crescent shaped banks around a hollowed centre, although burnt mounds are typically located close to watercourses there was no clear watercourse located nearby, although one is depicted on the modern OS.

**Photo 4.4: View of burnt mound MM02 looking north-west**

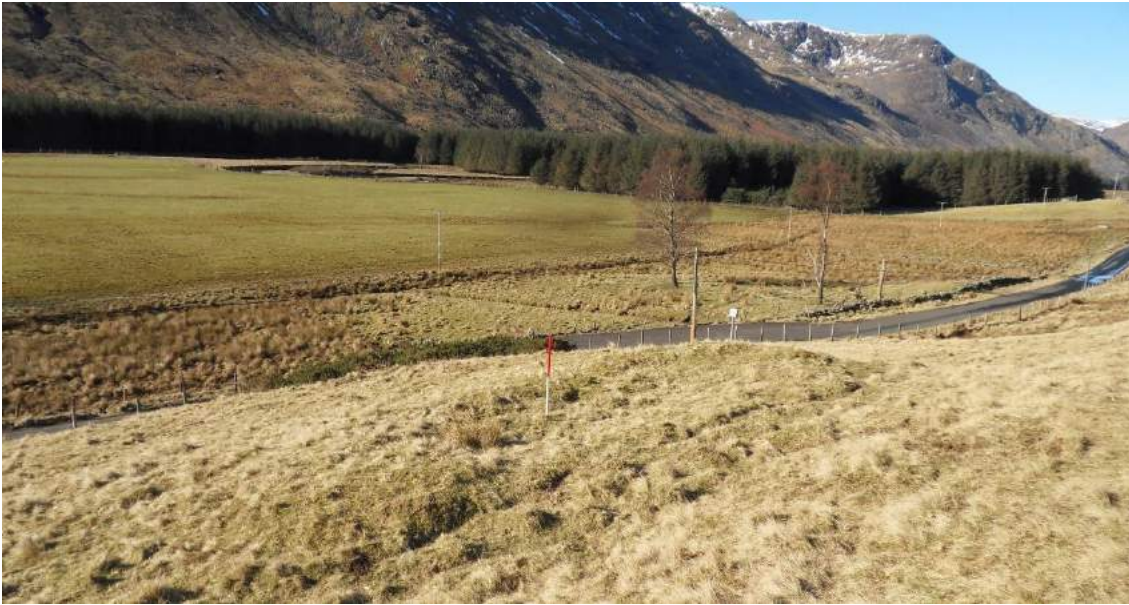
The study areas contained large numbers of sub rectangular buildings, generally surviving as earthen footings or foundations with dipped interiors (Photo 4.5).

**Photo 4.5: View west across building MM40**

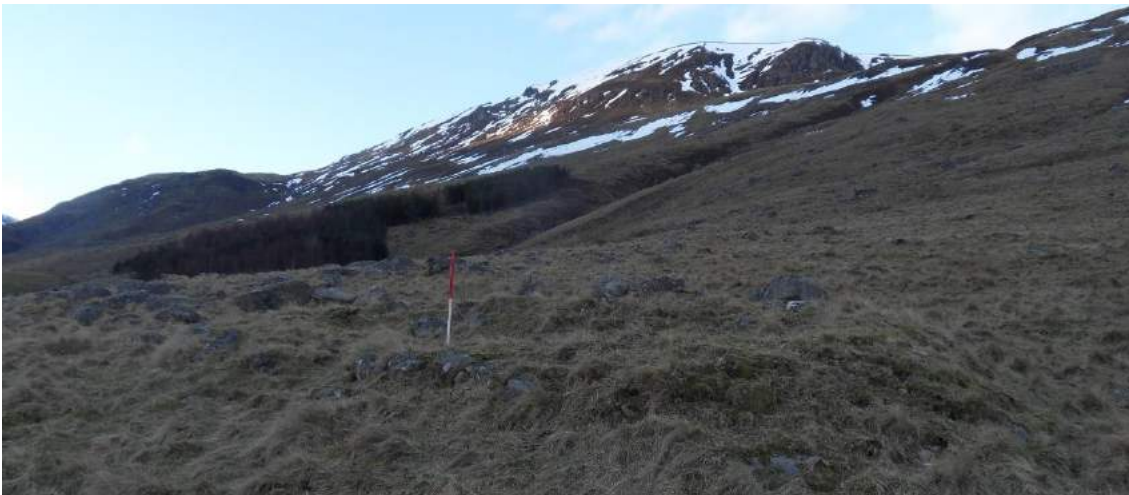
While stone footings were often apparent forming the foundations of the structure (Photo 4.6), the buildings appear to have been almost entirely constructed from earth. Even in those cases where the abundant stones of Glen Clova were used to form foundations, these buildings would be predominantly of earth and turf construction, low dwellings with heather or grass thatch.

**Photo 4.6: View of the stone foundations of building MM95 looking north**

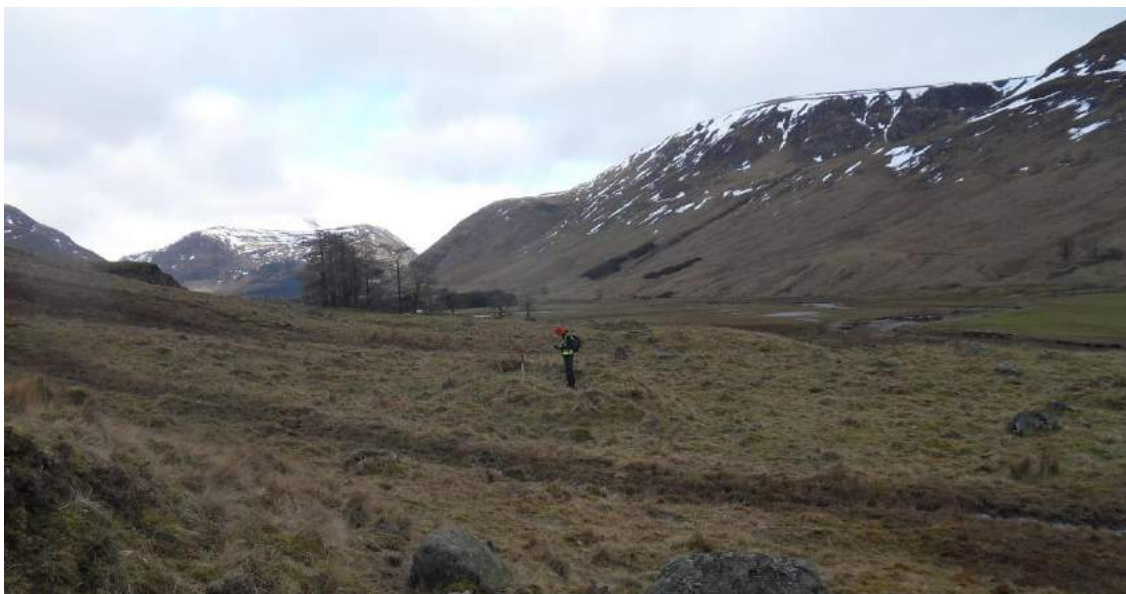
The township recorded at Atton (MM10) revealed at least 11 individual structures (Photo 4.7) spread out along the base of the hillside above the River South Esk, with an enclosure, possible field system, and substantial earthen bank or head dyke.

**Photo 4.7: Working shot showing recording of MM10e looking north-west**

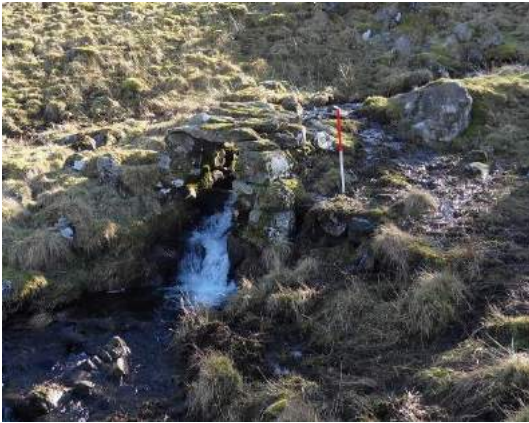
The settlement at Clayleith (MM18) was recorded by the RCAHMS and was depicted on William Roy's map of c.1750, remaining occupied in the 1860s when the OS first edition was compiled, but falling out of use by the 2<sup>nd</sup> edition c.1900. The remains at Clayleith (MM18) are substantial, complex and an outstanding example of post improvement farmstead where elements of pre-improvement occupation survives. At least eight buildings or possible buildings of varying sizes were recorded (including MM18j – Photo 4.10), with enclosures, clearance cairns, banks, land boundaries and drystone walls. A track was also recorded, crossing a possible ford and two clapper bridges (MM18a and MM18f – Photo 4.8 and Photo 4.9).

**Photo 4.8: View south-east across possible eroded clapper bridge MM18a**

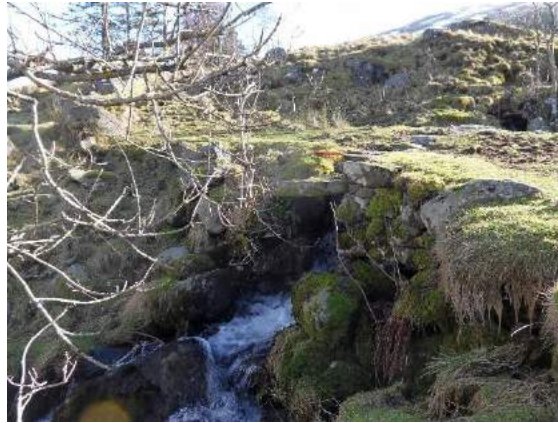
**Photo 4.9: Surviving clapper bridge MM18f crossed by track MM18b, looking south-east**

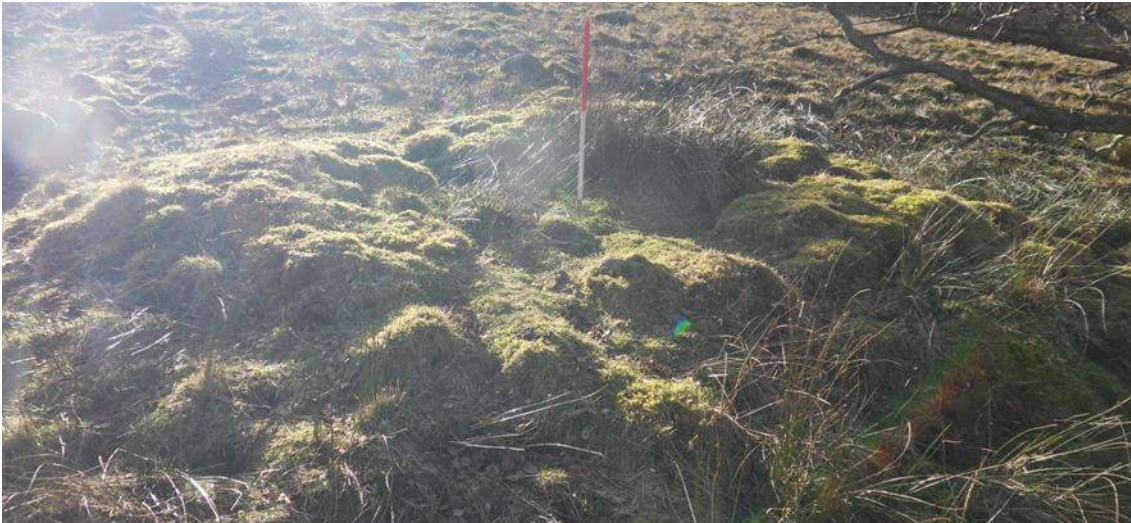
**Photo 4.10: View south across building MM18j**

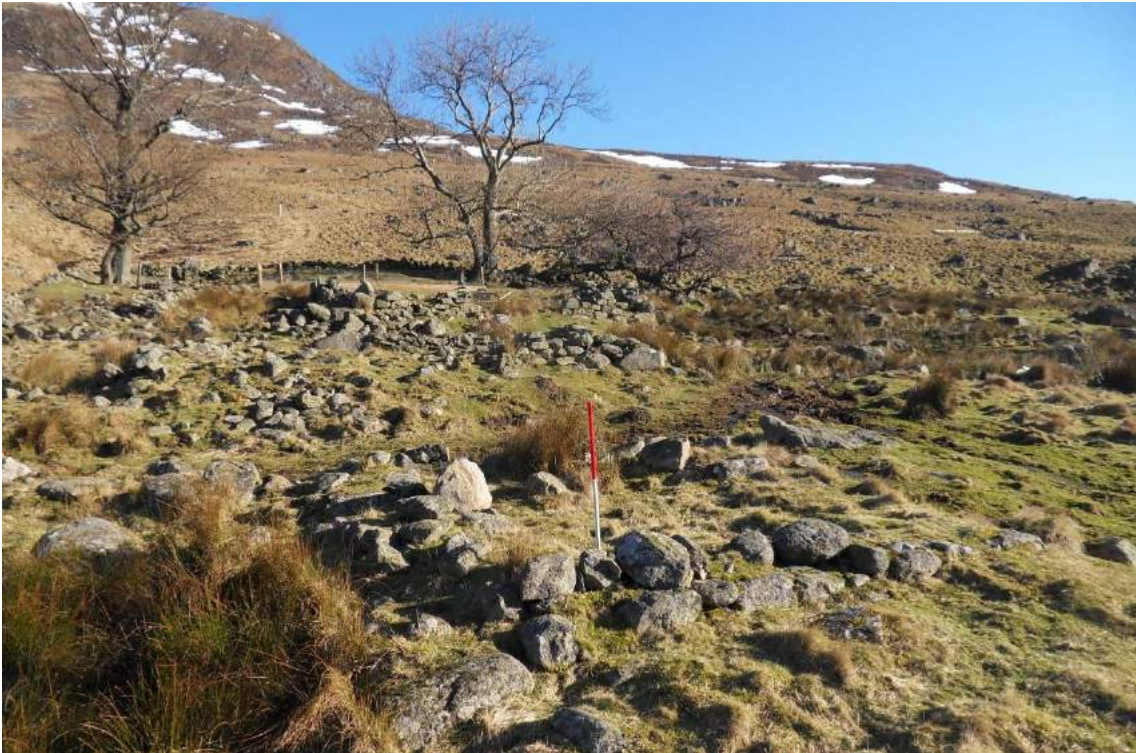
At Langholme (MM44), the buildings are more substantial (Photo 4.11) than the majority of the assets recorded. Clearly these buildings were constructed from stone with squared corners and are clearly laid out in relation to one another. In addition, there are sheepfolds (MM44a); enclosures (MM44d, MM44i, MM44n); drystone walls and banks (MM44f); and a revetted trackway (MM44g). The occupation of Langholme is recorded by Roy's map c.1750, but is marked as 'ruins' by the OS c.1860.

**Photo 4.11: View of farmstead MM44h and associated structures looking north**

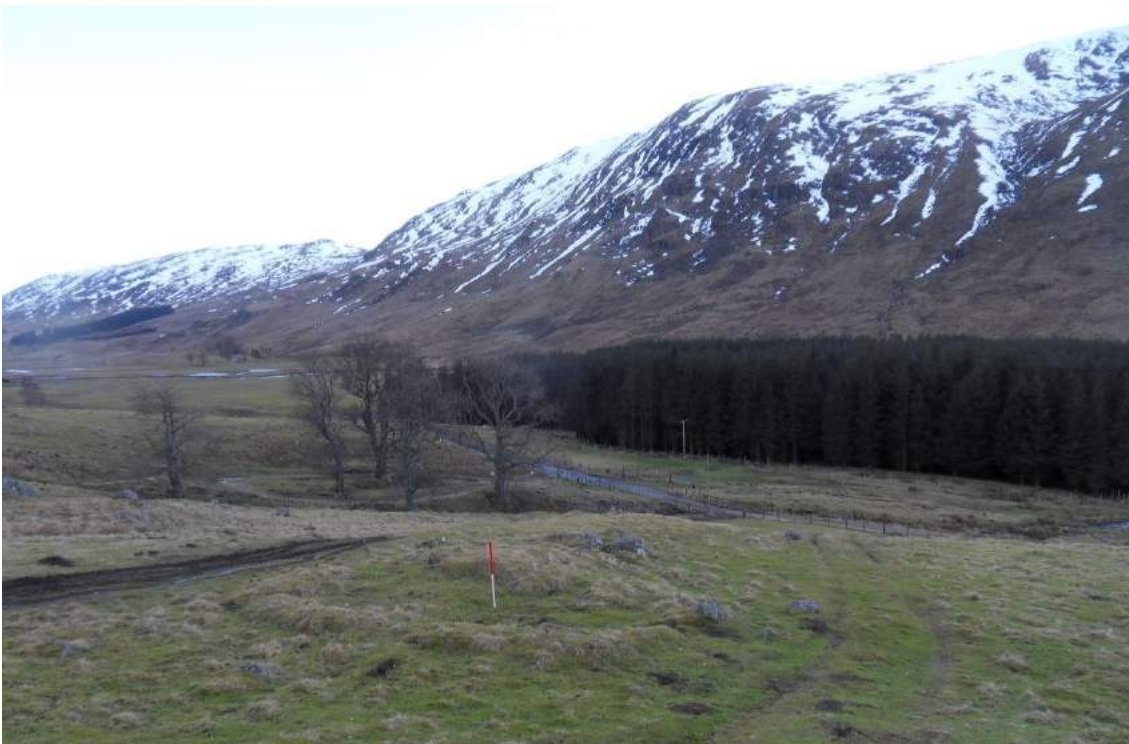
**Photo 5.1: View south across building MM38g**
