EAST NETHERSHIELDS ROAD SAFETY REVIEW OF TIMBER EXTRACTION JUNCTION

ROAD SAFETY REVIEW
(SPA Ref No: 5564)

Roads Authority: South Lanarkshire Council

Client: Tilhill

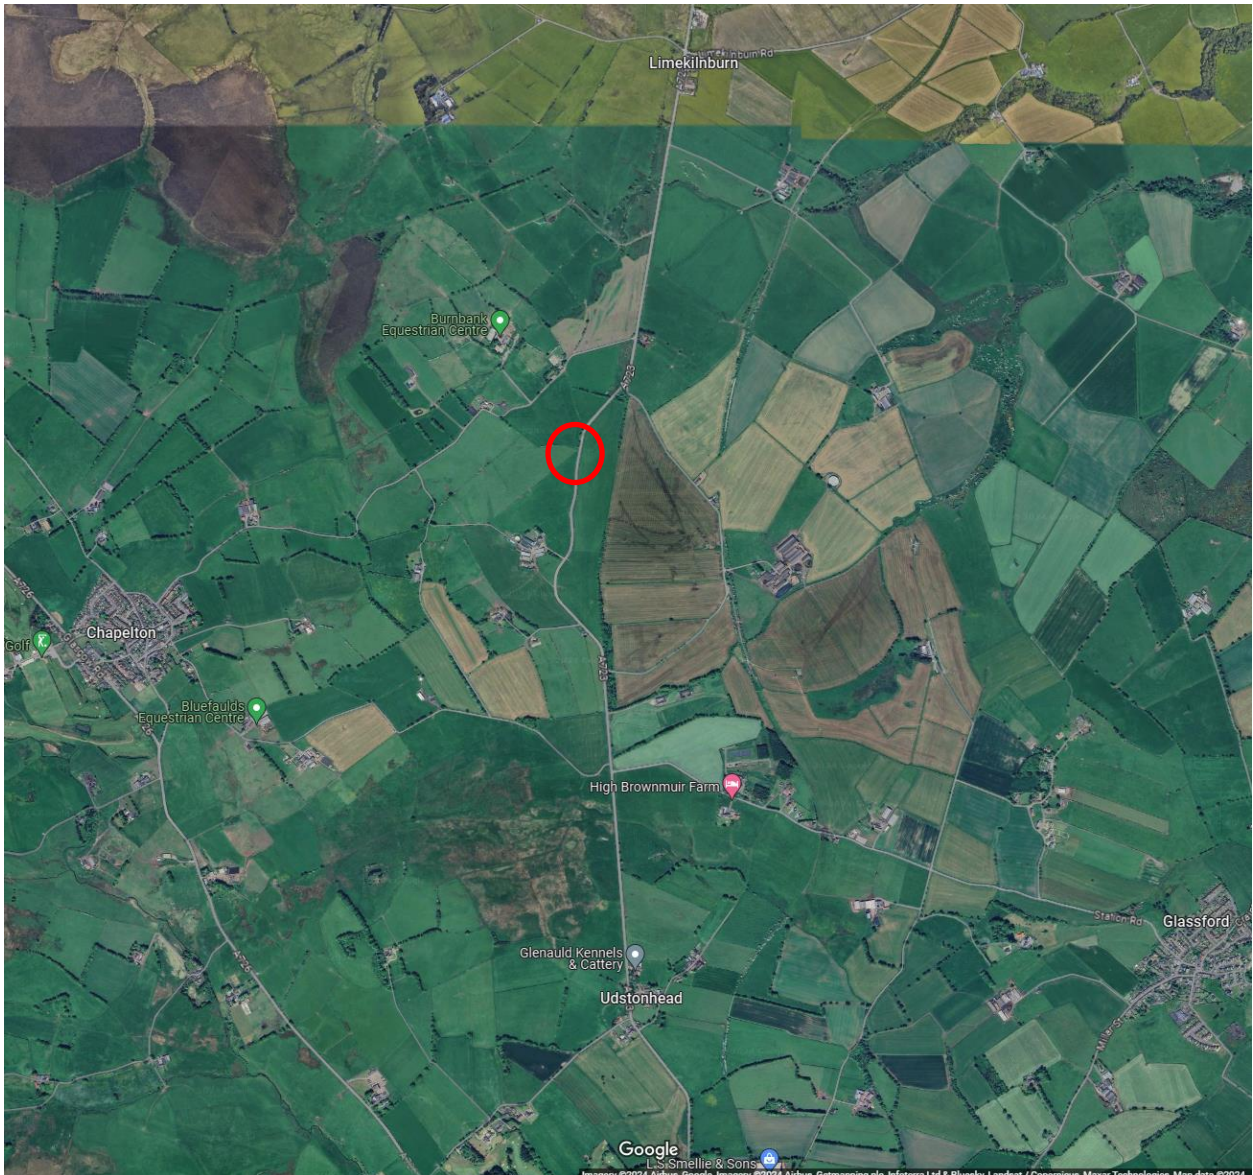
4.2 It can be seen from the image above that, when heading south to north, the A723 is relatively straight. However, to the south and north of the access junction there are a series of bends.

4.3 The sequence of bends are as follows when leaving the straight section of road heading northwards.:

- Left
- Right
- Left

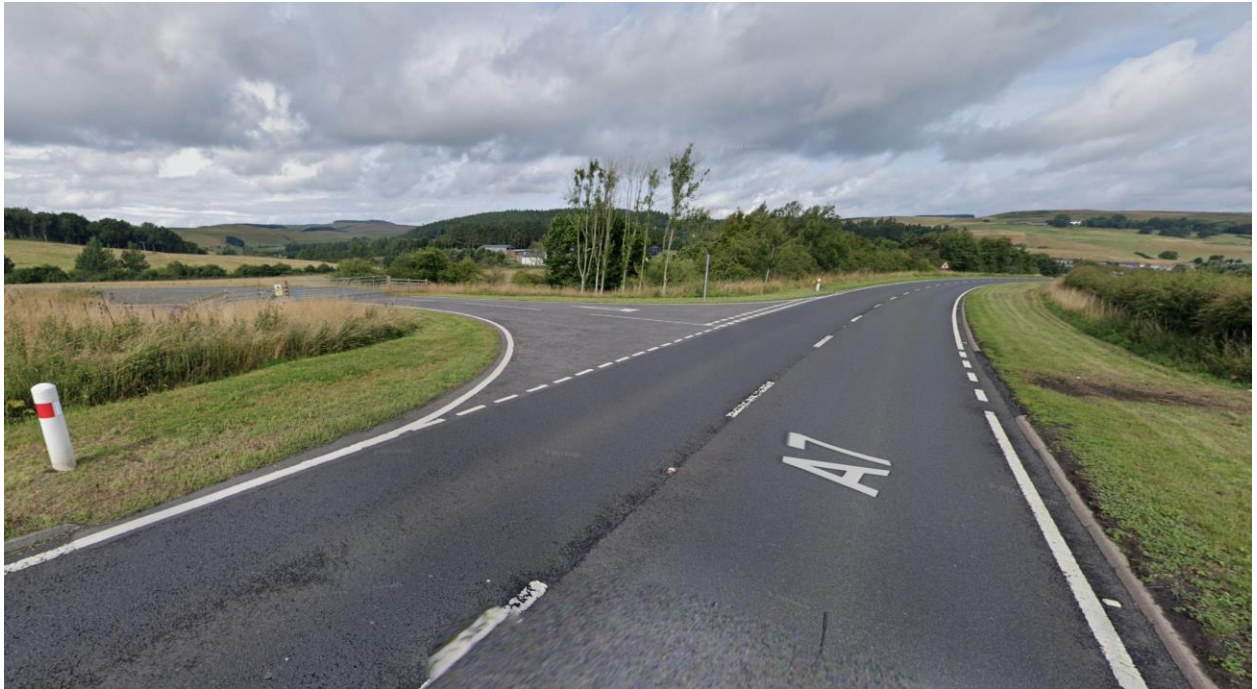
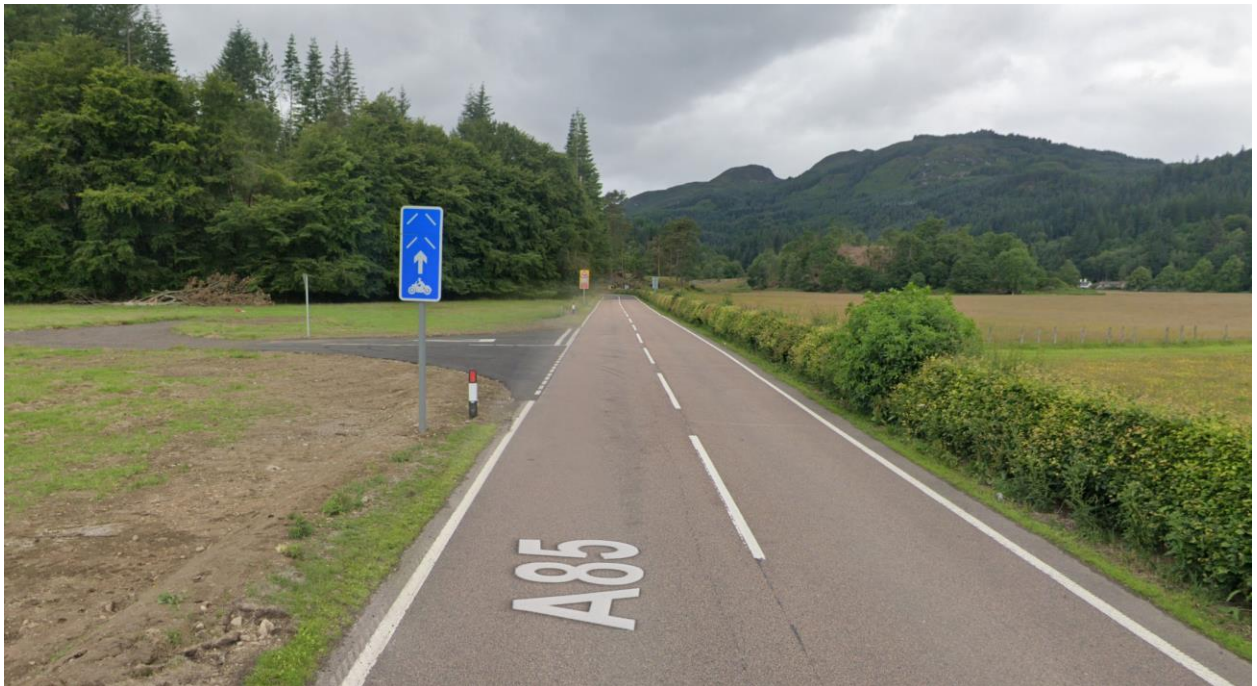
7.2 The images (from Google Maps) below show typical access junctions provided for timber extraction.

7.3 If a similar sized junction was to be provided on the A723 there would need to be extensive clearing of the verge.

7.4 It is likely that the northern extent of any junction would be restricted by the trees to the north.
