Road Safety Review: Tilhill Addendum

The following addendum explains how the recommendations of the Road Safety Review have been incorporated into the woodland design. The photos demonstrate the current line of sight from each junction where road safety has been highlighted. The woodland design ensures that the current line of sight from each junction is not compromised by tree planting. Further illustration may be found on the map titled 'Public Road Safety'.

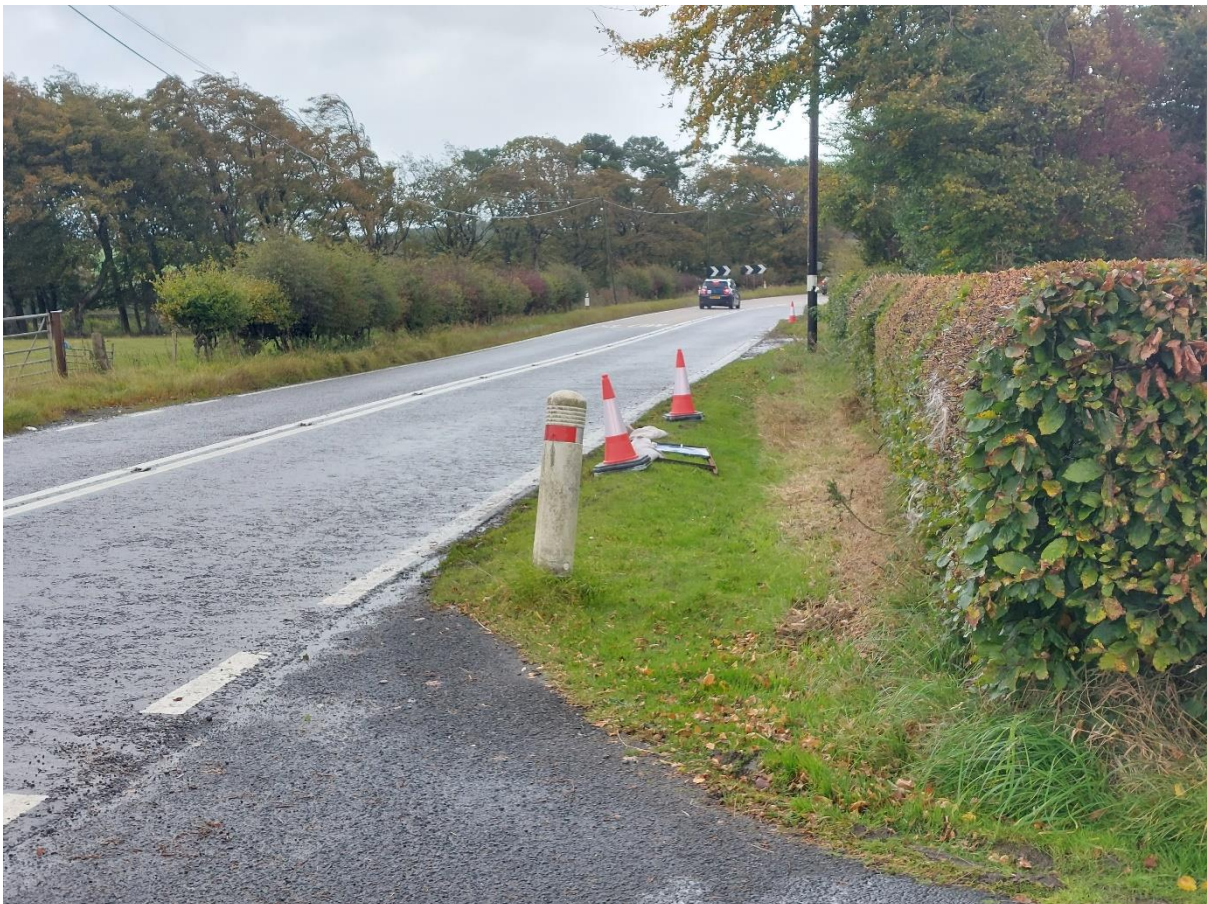
1. Maiden Lea junction

Figure 1. A723 looking south. Sight line to bend only. Tree planting will not affect this sight line.

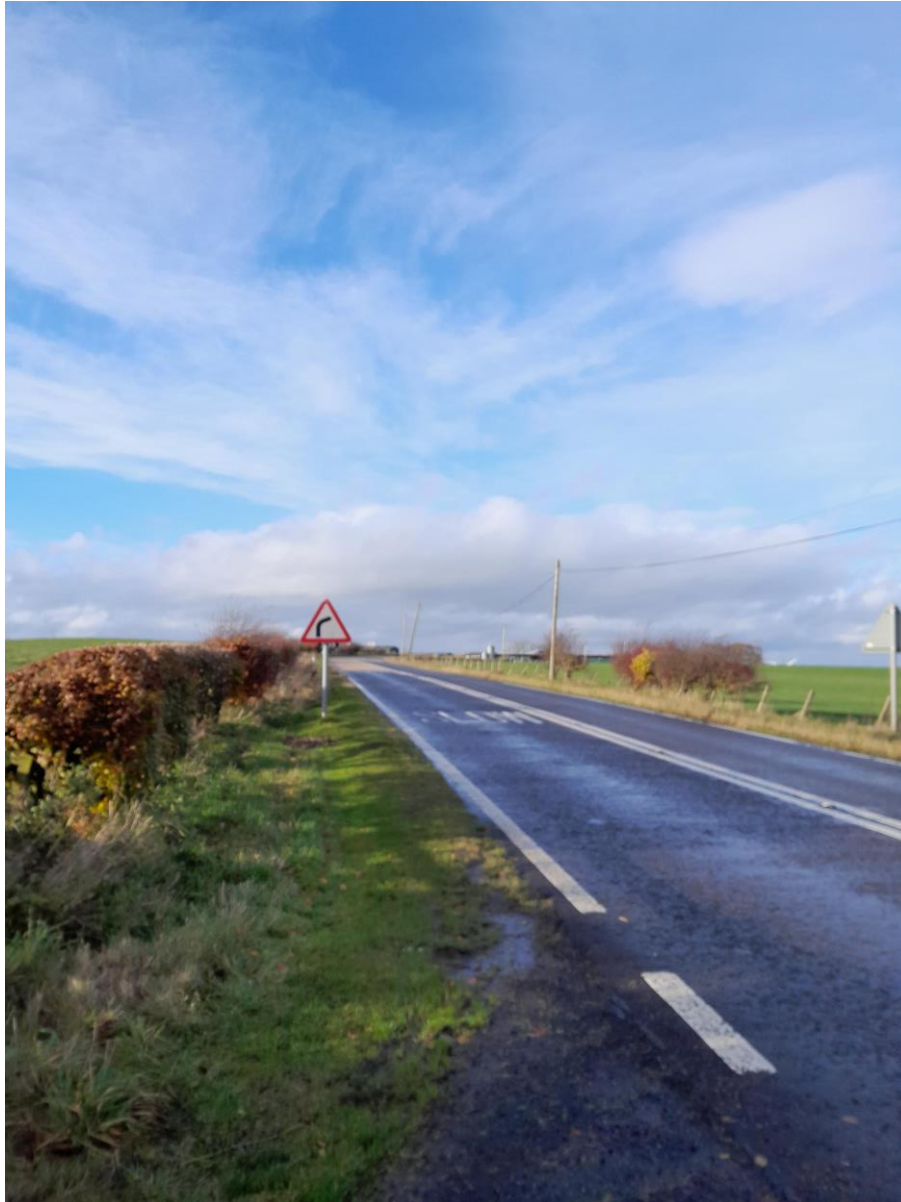
Figure 2. A723 looking north. The sight line reaches the bend of the A723 adjacent to East Nethershields Farm. A 5-metre buffer has been created around this sight line and the tree design in the field to the east of this bend has been reduced accordingly.

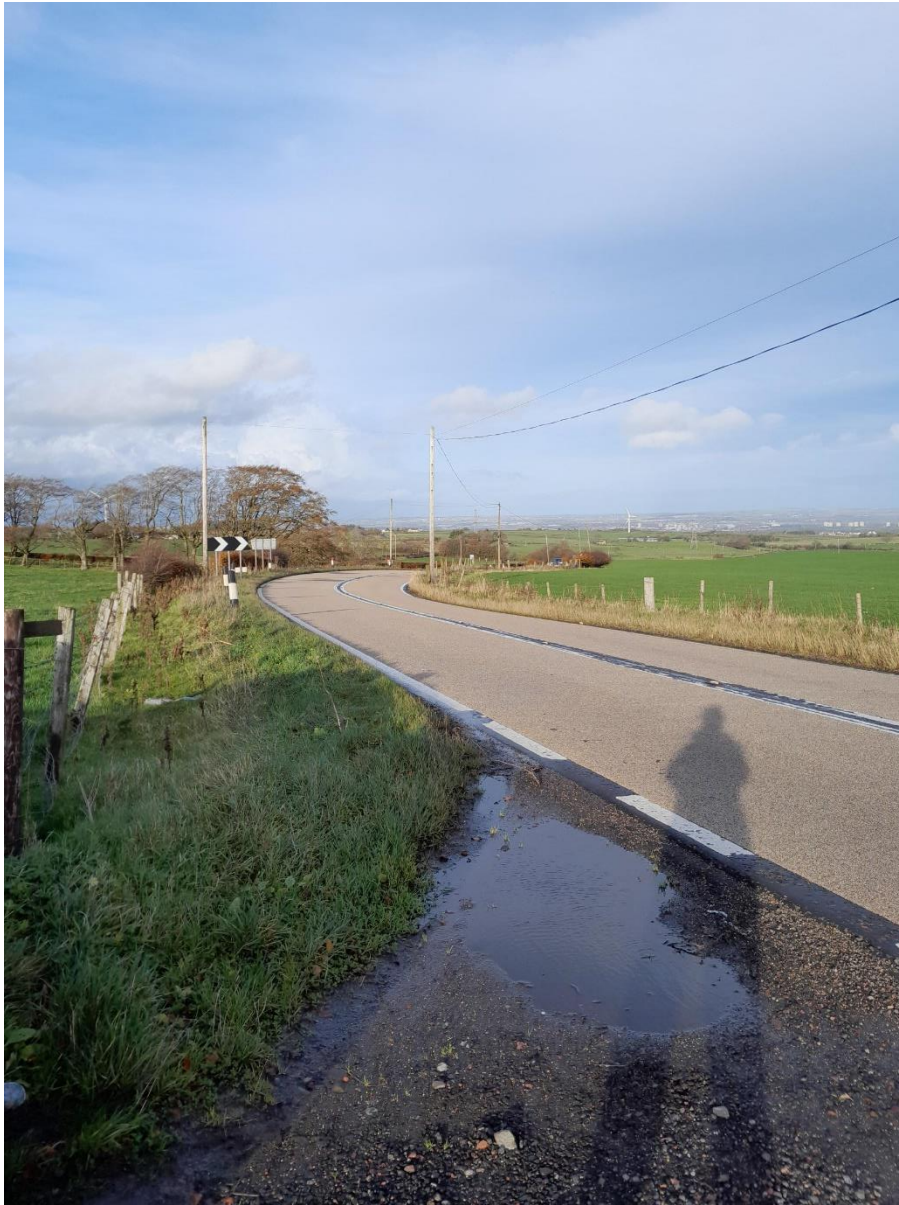
2. East Nethersields Farm (entrance) junction

Figure 3. Sight line looking north along the A723. A 5-metre buffer has been created around this sight line and the tree design in the field to the east of the road has been reduced accordingly.

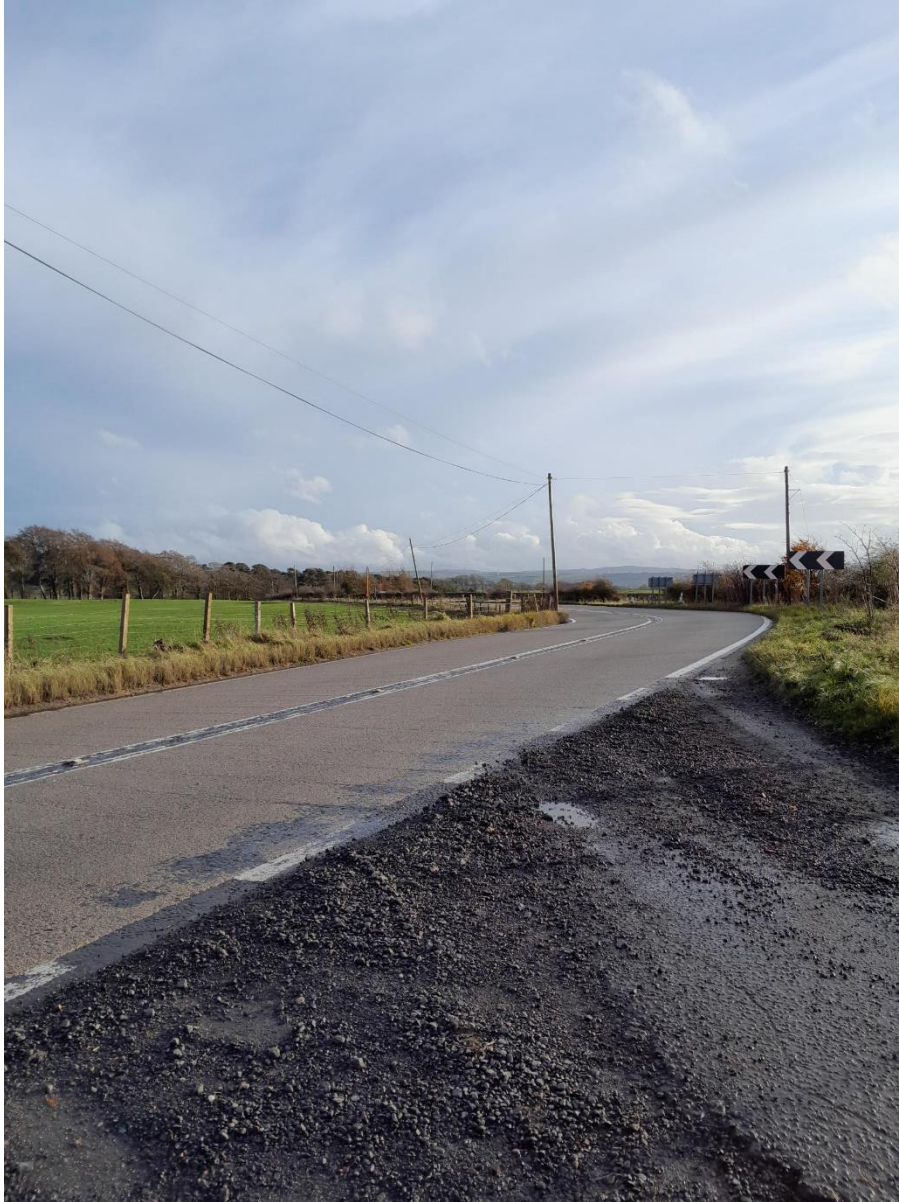
Figure 4. Sight line looking south along the A723. A 5-metre buffer has been created around this sight line and the tree design in the fields to the east and west of the road have been reduced accordingly.

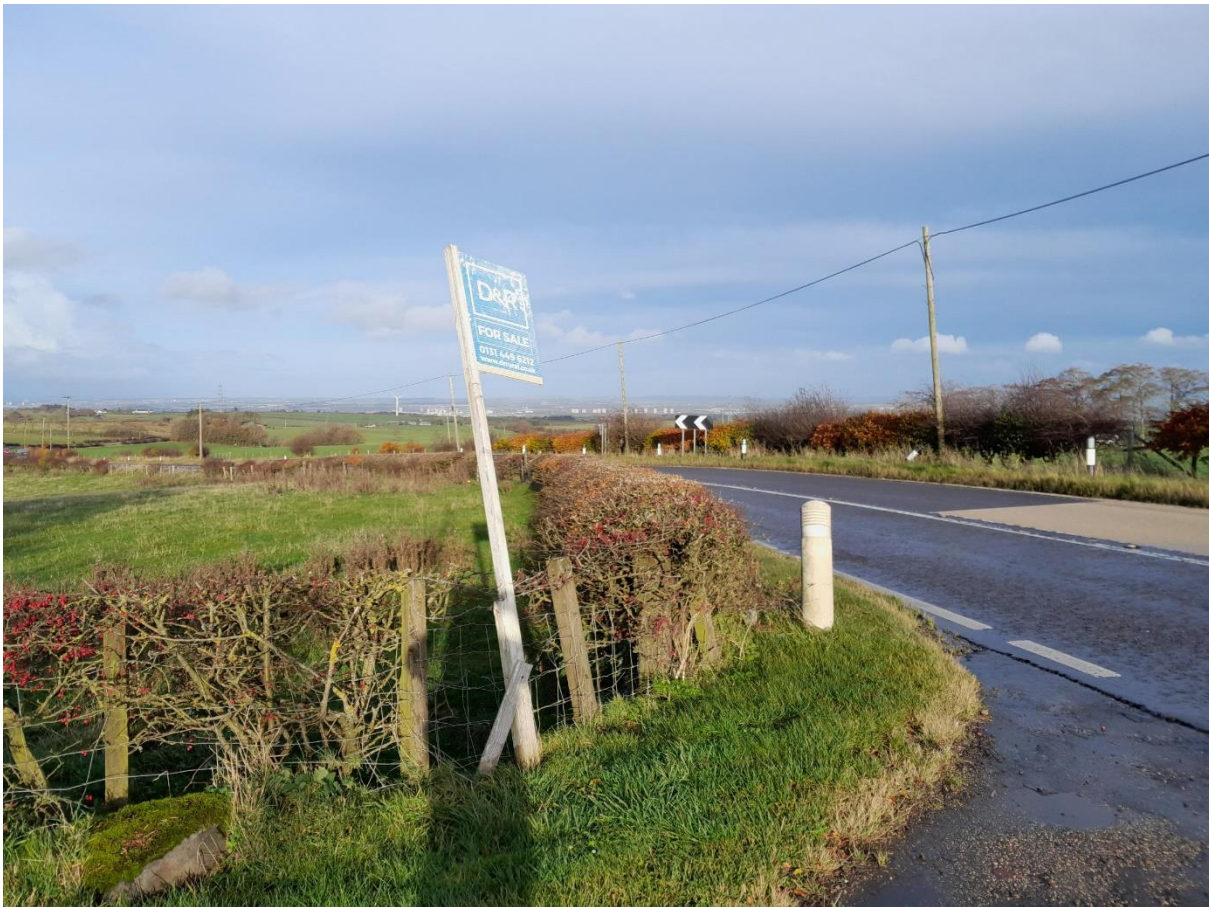
3. East Nethershields Farm (exit) junction

Figure 5. Sight line looking northeast along the A723. Tree planting will not affect this sight line.

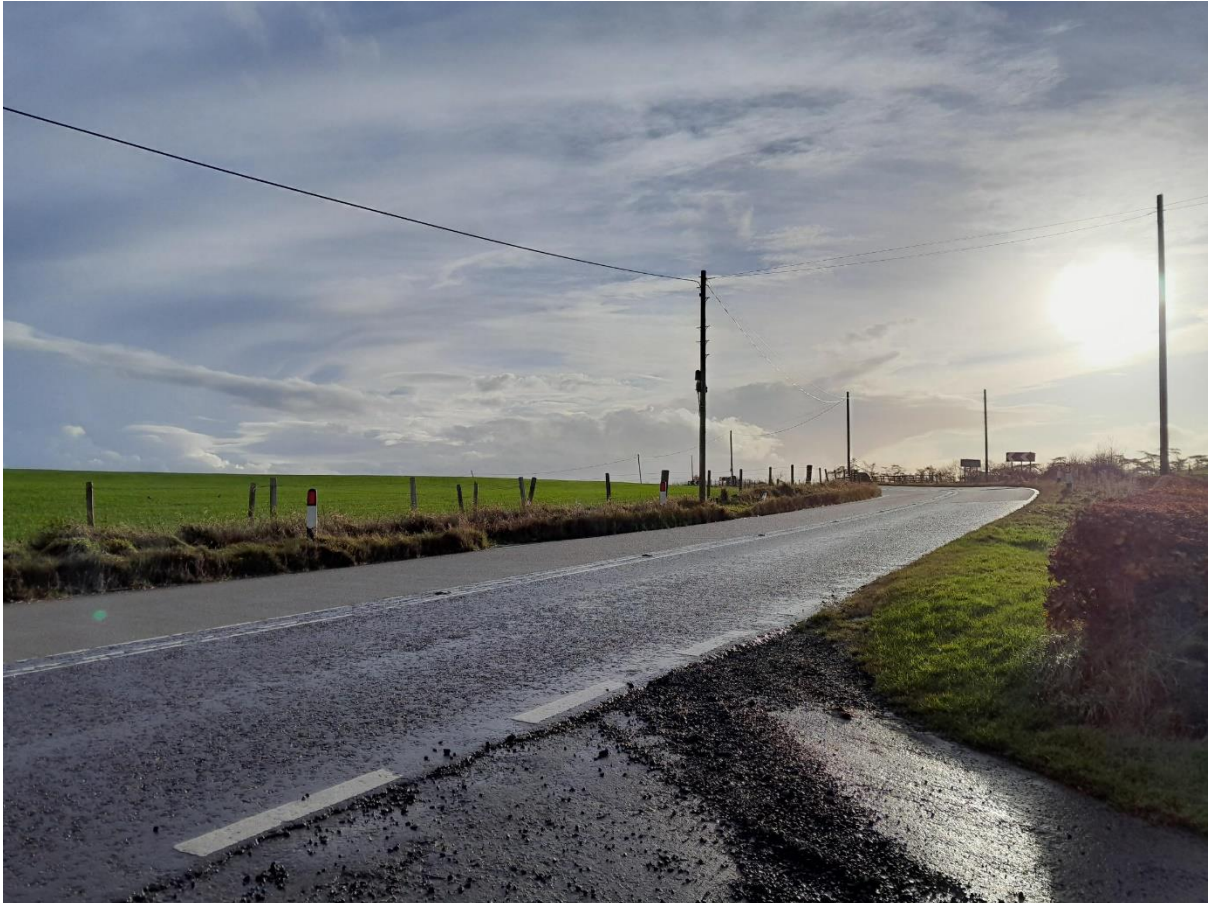
Figure 6. Sight line looking southwest along the A723. A 5-metre buffer has been created around this sight line and the tree design in the field to the east of the A723 has been reduced accordingly.

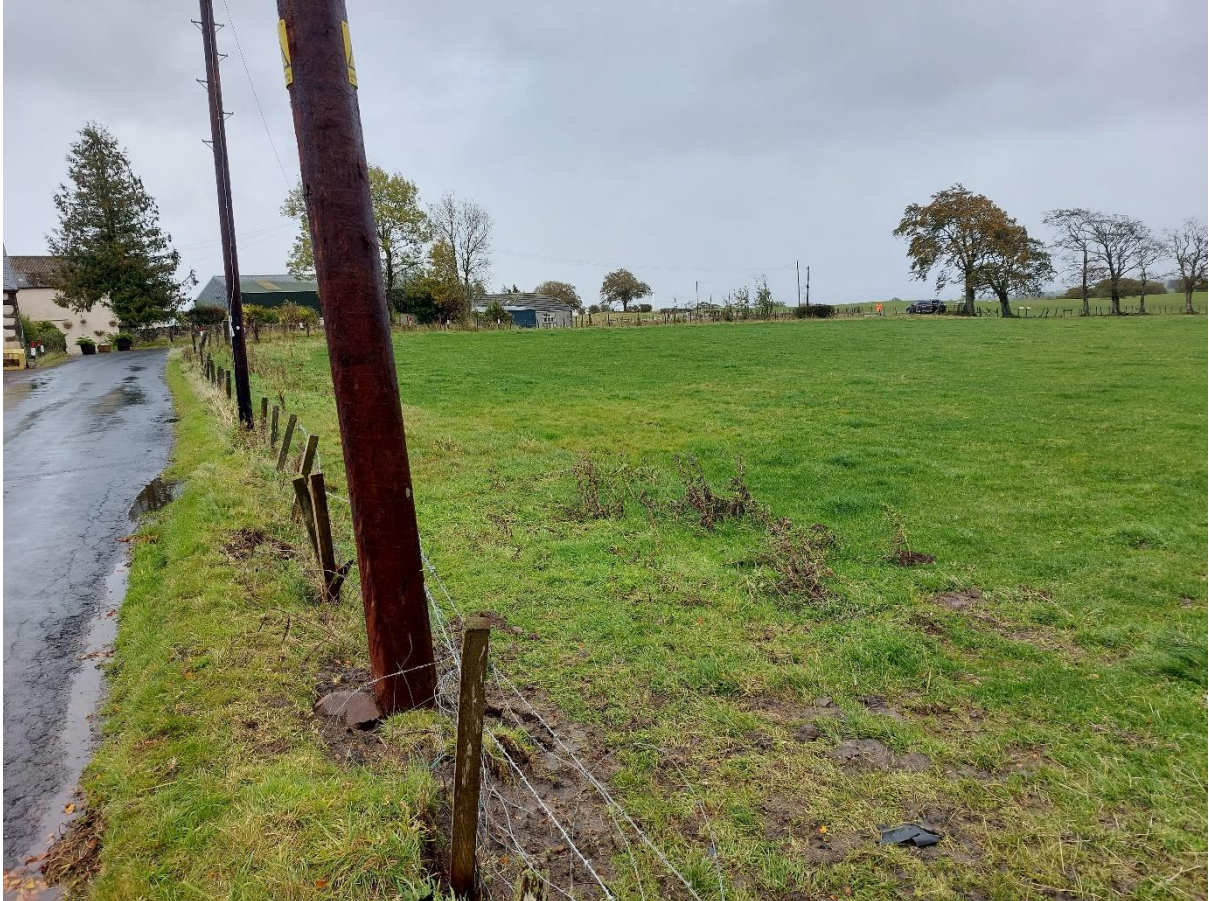
4. Burn Road S bend

Figure 7. Burn Road looking east towards the S bend corner. Tree planting which would restrict this line of sight has been removed from this corner of the field.

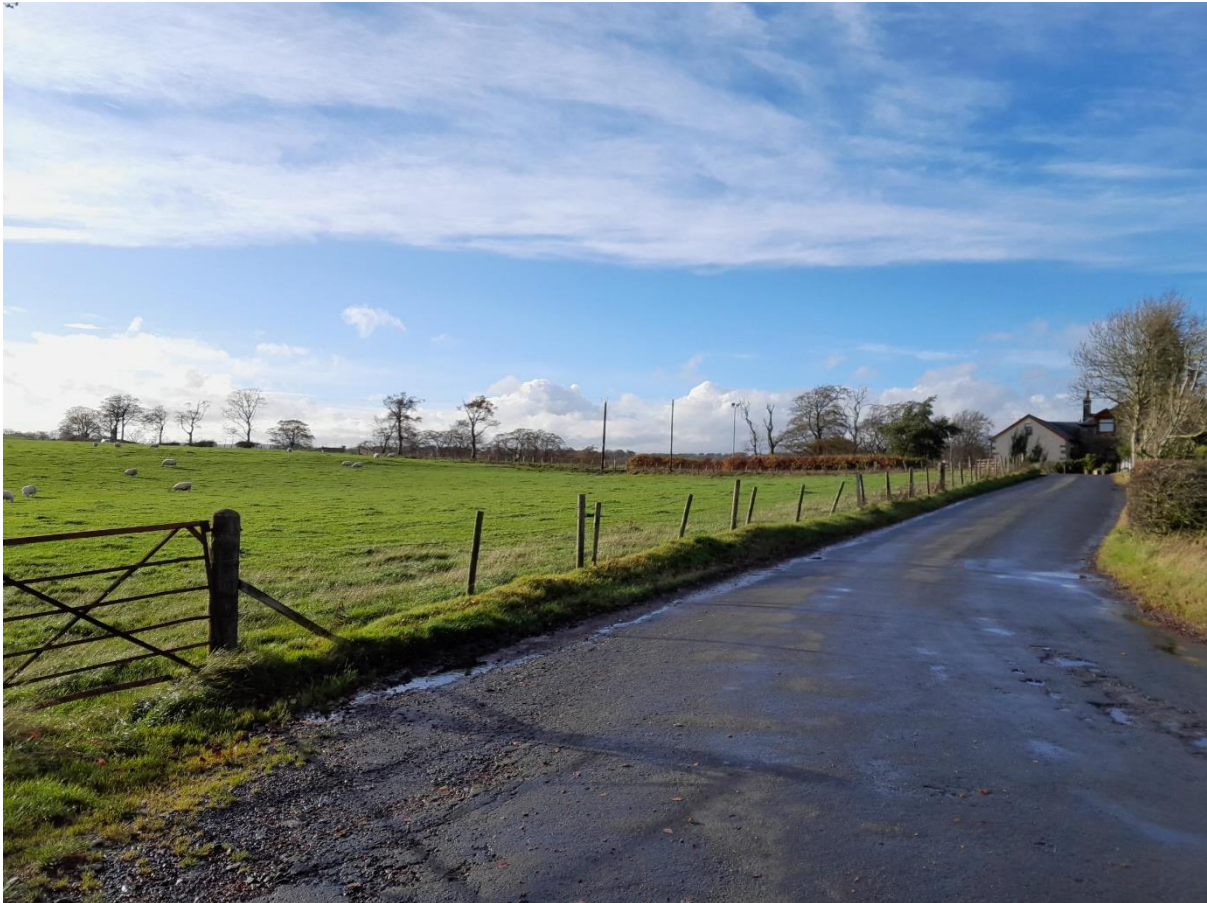
Figure 8. Burn Road looking west towards the S bend corner. Tree planting which would restrict this line of sight has been removed from this corner of the field.

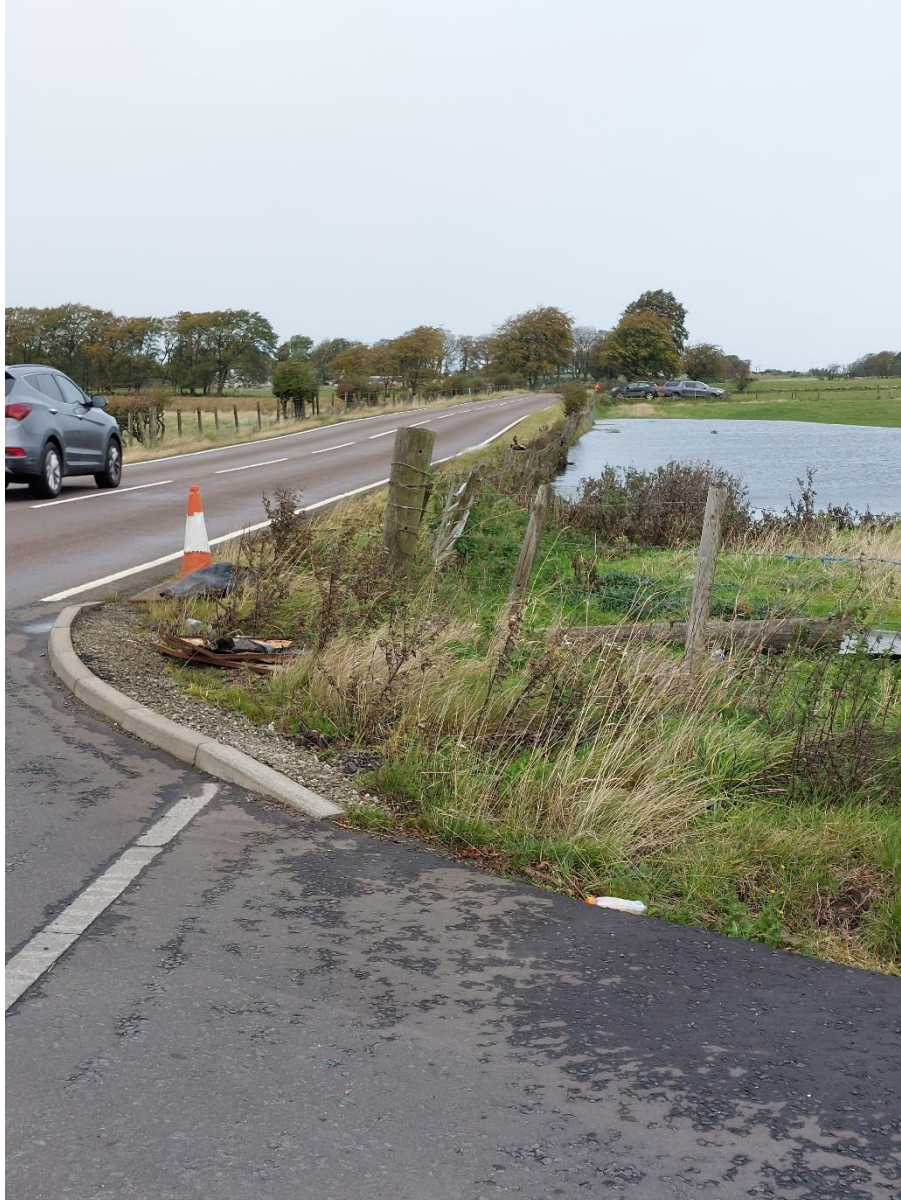
5. Cloverhill access driveway

Figure 9. Cloverhill access looking north along the A726. A 5-metre buffer has been created around this sight line and the tree design in the field to the east of the A726 has been reduced accordingly.

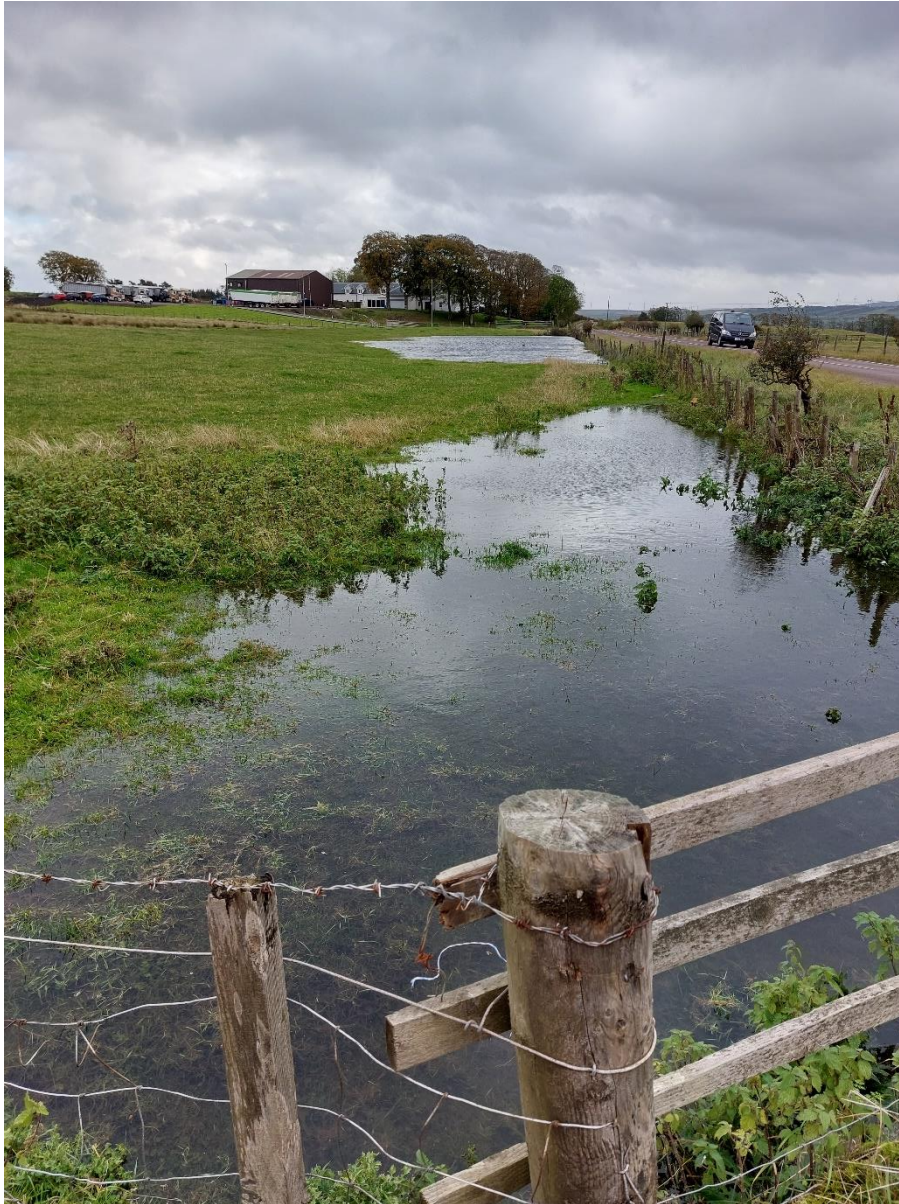
Figure 10. Cloverhill access looking south along the A726. A 5-metre buffer has been created around this sight line and the tree design in the field to the east of the A726 has been reduced accordingly.
